EFFECTS OF 'BLACK STEEL' AND ITS CONTRIBUTION TO PREMATURE BRAKE PAD REPLACEMENT AND BRAKE PAD FAILURE

Abstract

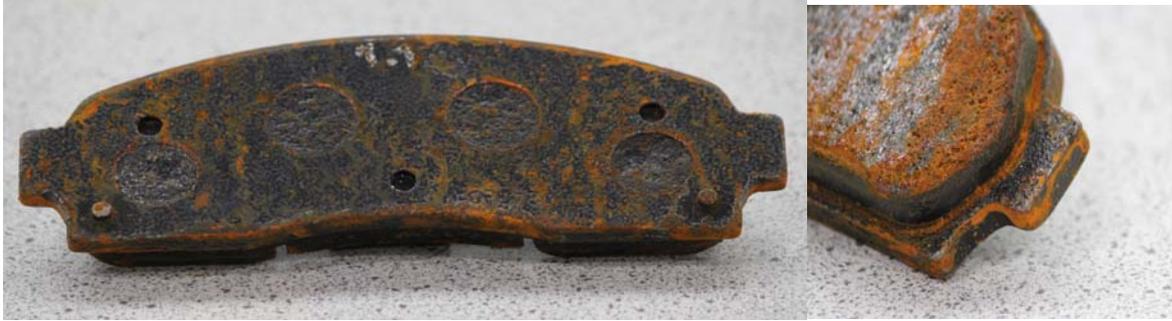
Figure 8 - Sample 1.1 - Economy grade-1 (20 Hours)

- Significant red rust visible around the edges and corners, particularly areas where the paint was compromised during the tumbling process.
- Heavy red rust build-up between the disc brake shoe surface and the entire lining perimeter.
- Visible red rust on disc brake shoe surface already exceeds OEM specification of 5% maximum after 96 hour salt spray.
- Red rust formation visible on surface of semi-metallic lining material.

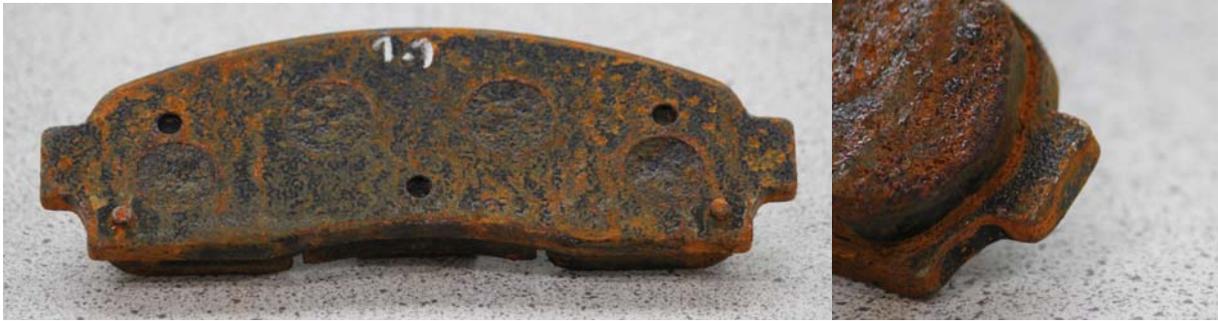
Figure 12 - Sample 1.1 - Economy grade-1 (40 Hours)

- Increasing red rust visible around the edges and corners.
- Red rust build-up between the disc brake shoe surface and the lining perimeter expanding.
- Visible red rust on disc brake shoe surface exceeding 25%.
- Red rust formation increases on the surface of semi-metallic lining material.

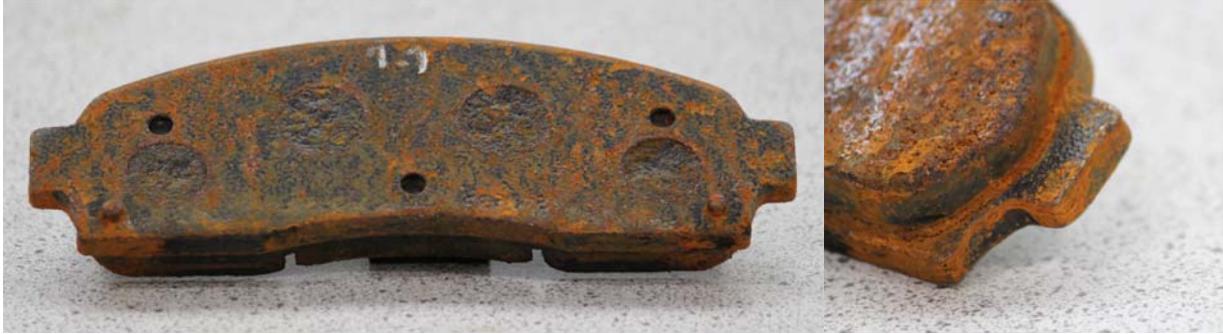
Figure 16 - Sample 1.1 - Economy grade-1 (60 Hours)

- Red rust prevalent on most edges and corners.
- Red rust build-up between the disc brake shoe surface and the lining perimeter continues to expand and shows signs of separation from the disc brake shoe surface.
- Visible red rust on the disc brake shoe surface increases to approximately 35%.
- Lining material begins to noticeably deteriorate from corrosion.

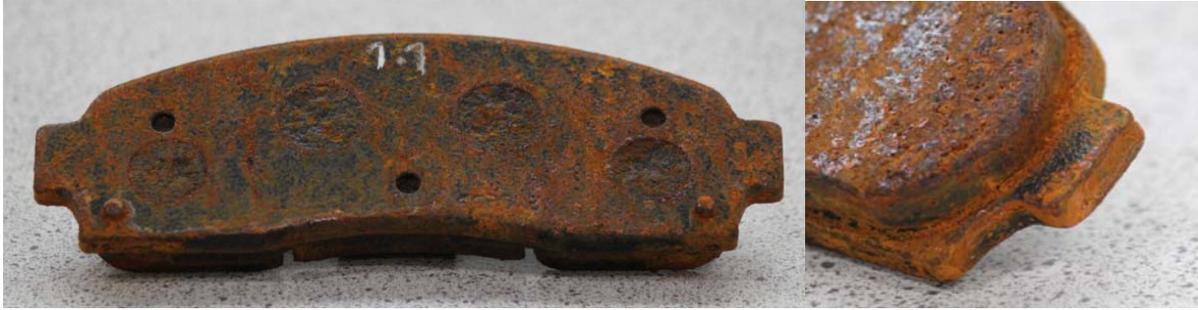
Figure 20 - Sample 1.1 - Economy grade-1 (80 Hours)

- Red rust prevalent on nearly all the edges and corners.
- Red rust build-up between the disc brake shoe surface and the lining perimeter continues to expand and shows an increased separation from the disc brake shoe surface.
- Visible red rust on the disc brake shoe surface exceeding 50%.
- Lining material continues to noticeably deteriorate from corrosion.

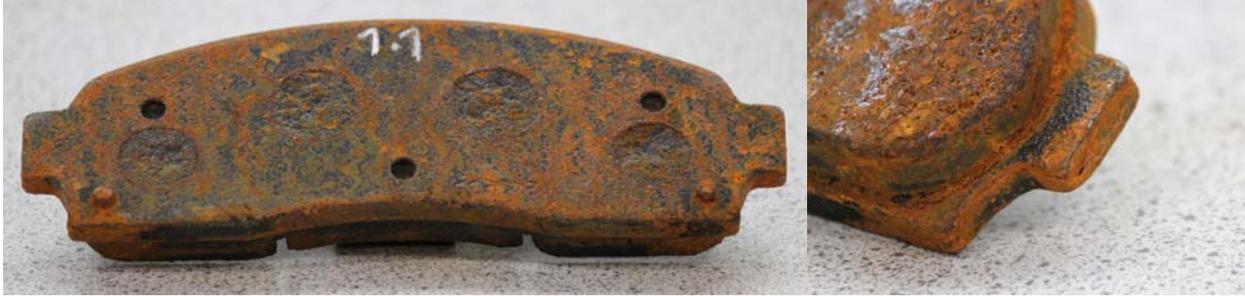
Figure 24 - Sample 1.1 - Economy grade-1 (96 Hours)

- Red rust still prevalent on nearly all the edges and corners.
- Red rust build-up between the disc brake shoe surface and the lining perimeter continues to expand and shows an increased separation from the disc brake shoe surface.
- Visible red rust on the disc brake shoe surface approaching 70%.
- Lining material continues to noticeably deteriorate from corrosion.

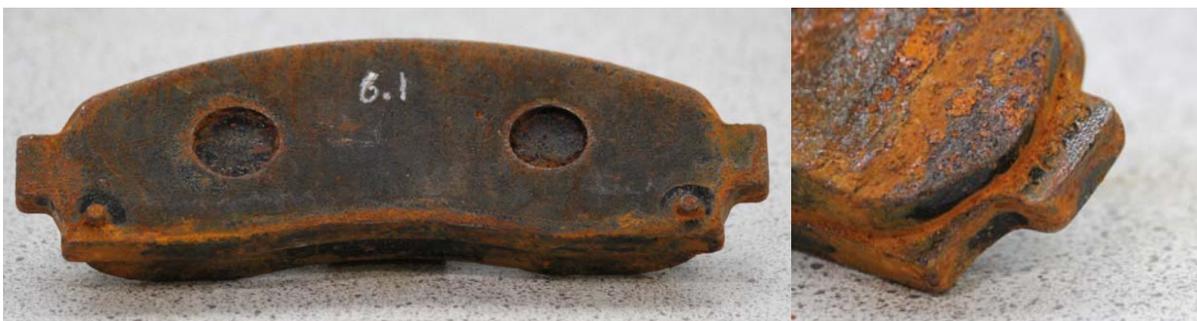
Figure 27 - Sample 6.1 - OES (96 Hours)

- Continued increase in red rust visible around the edges and corners.
- Red rust build-up between the disc brake shoe surface and lining perimeter continues to expand.
- Visible red rust on the disc brake shoe surface approaching 10%.
- Red rust flaking off the surface of lining material.

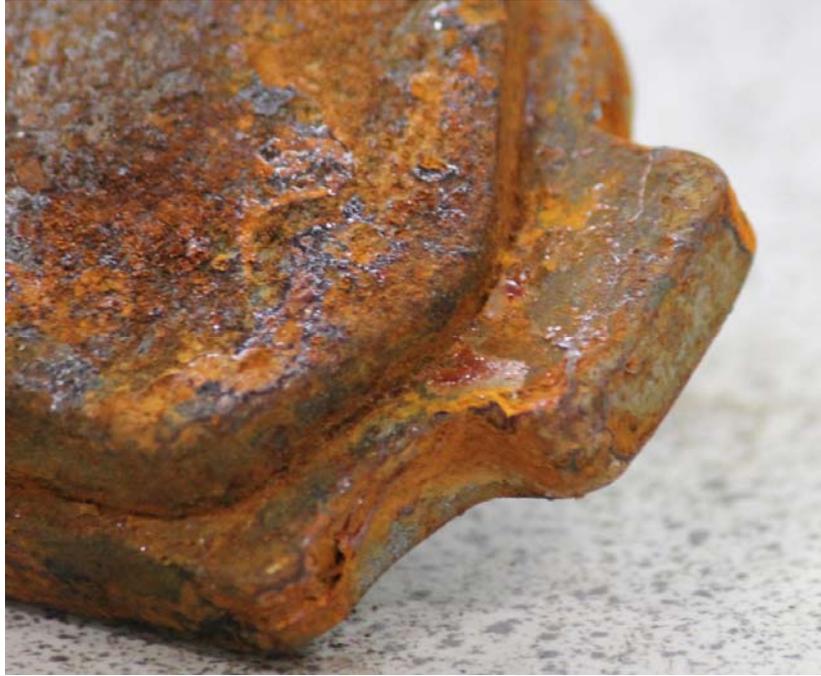
Figure 28 - Pad from sample set 3

- Pads from sample set 3 - different from the other grades - showed the greatest average increase in dimensions, 0.25 mm. Some dimensions increased by approximately 0.50 mm. Visual observation shows where large areas of paint that severely blistered off, which appears to have also rusted, possibly due to metal pigment content (see Figure 28).

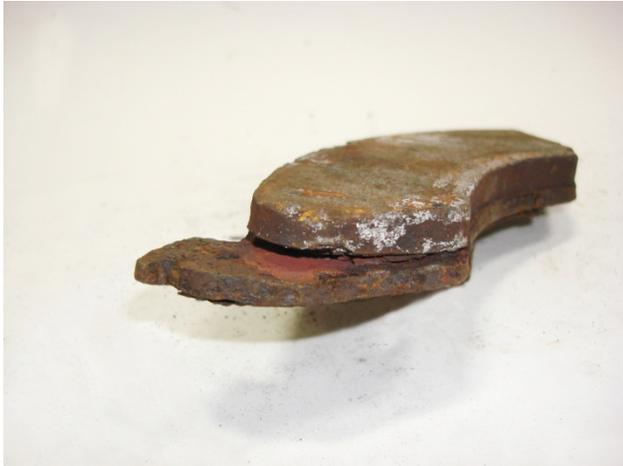
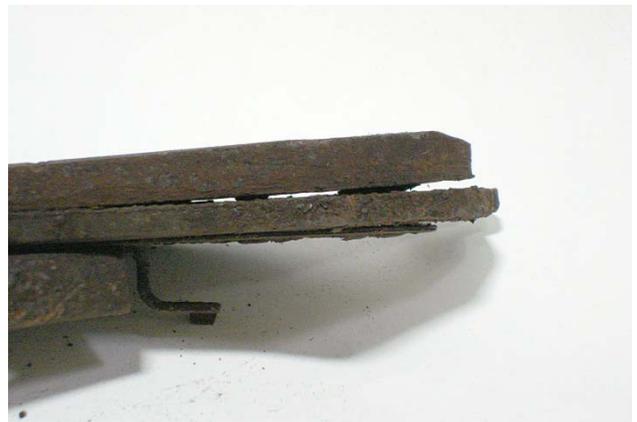
Figure 50 - Failed Disc Brake Pad Field Samples - Rust jacking

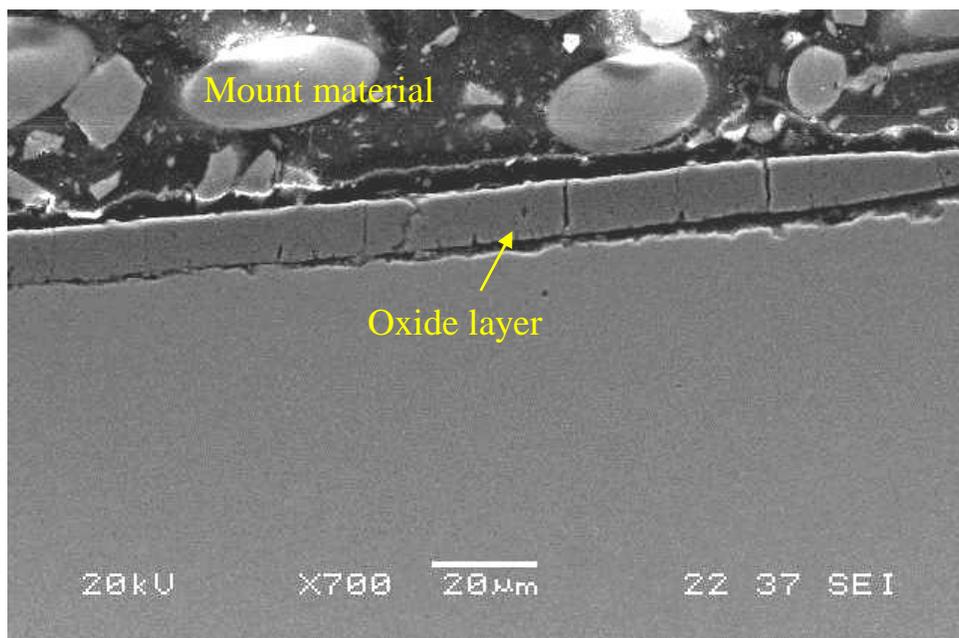
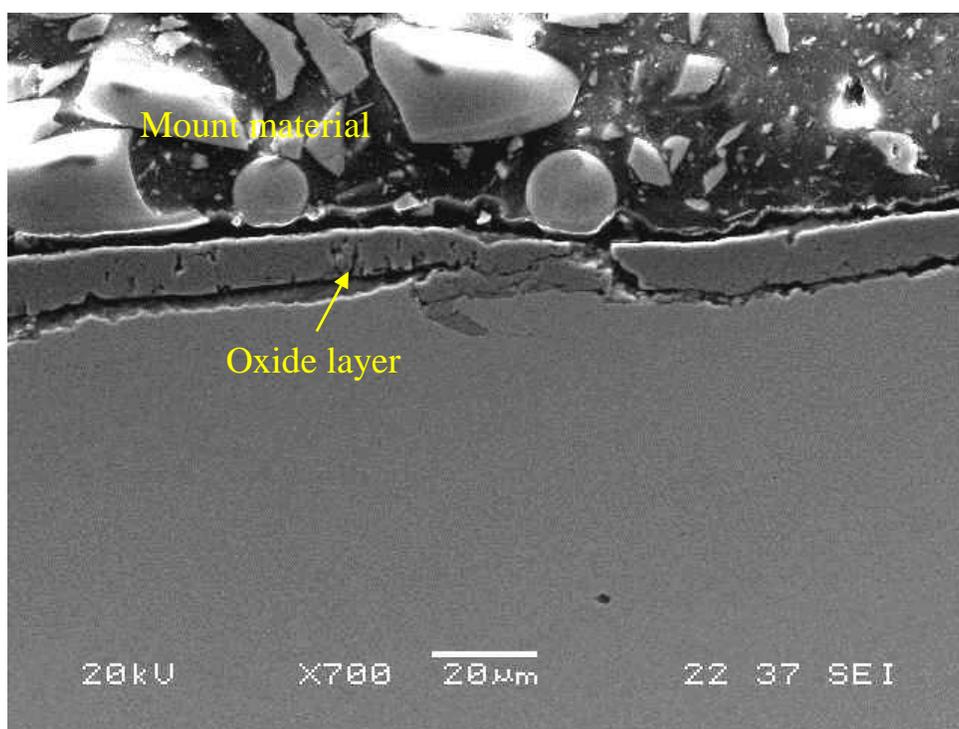
Figure 1: Selected SEM images of the surface of sample “1” black mill scale steel Q235B (5”x2”) illustrating the presence of a continuous oxide layer on the surface.

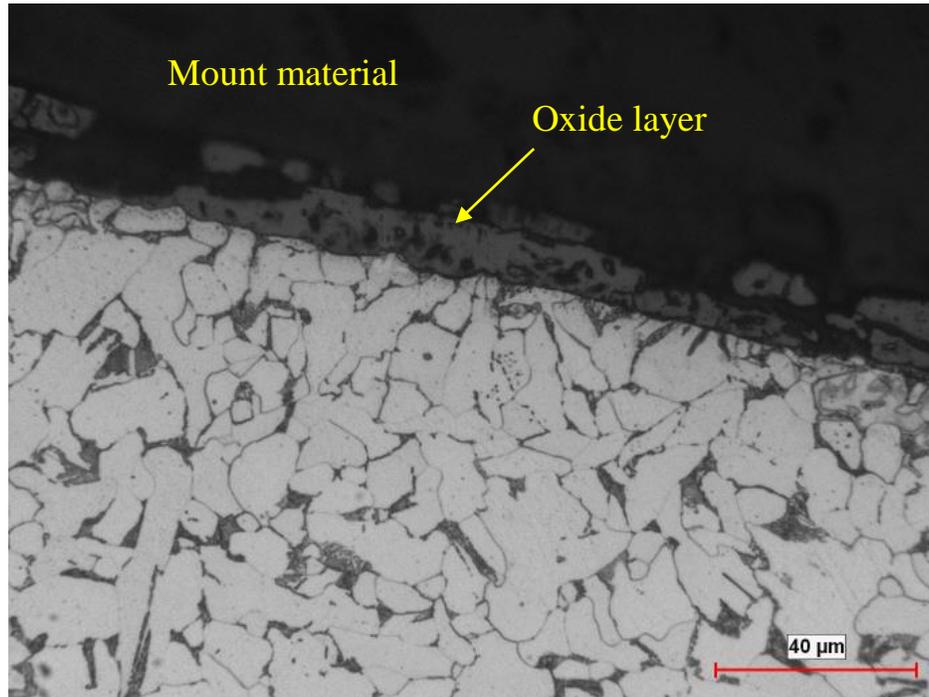
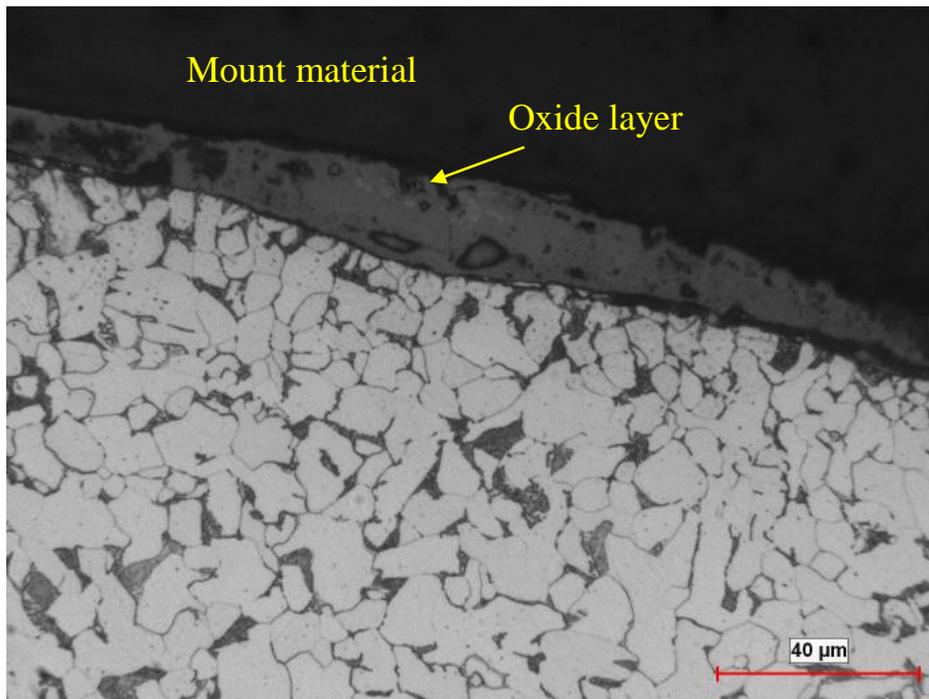
Figure 2: Optical micrographs showing the microstructure of sample "1", black mill scale steel Q235B (5"x2") at the surface. A superficial oxide layer is noted. The microstructure was composed of ferrite (light) and pearlite (dark). No grain deformation was observed (etched with 3% Nital, original magnification: 500X).

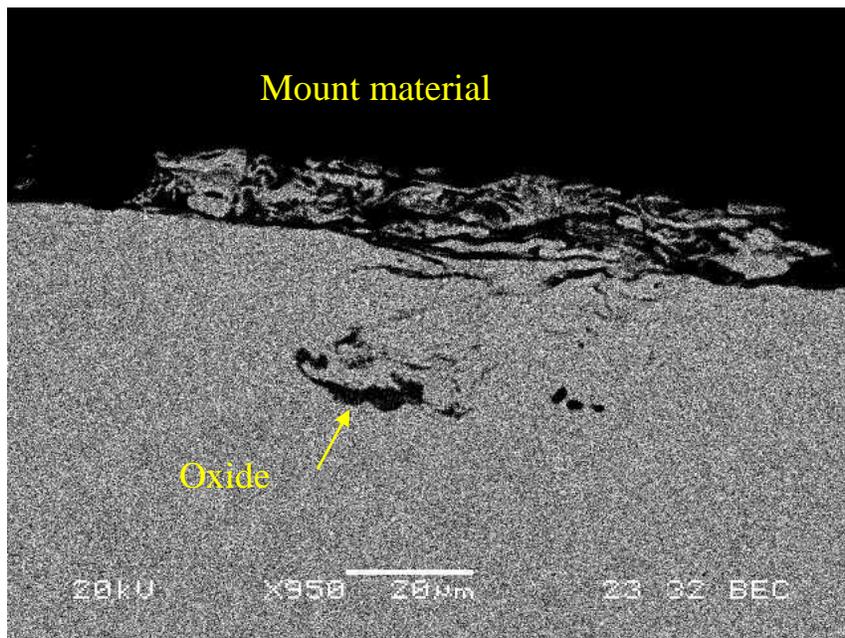
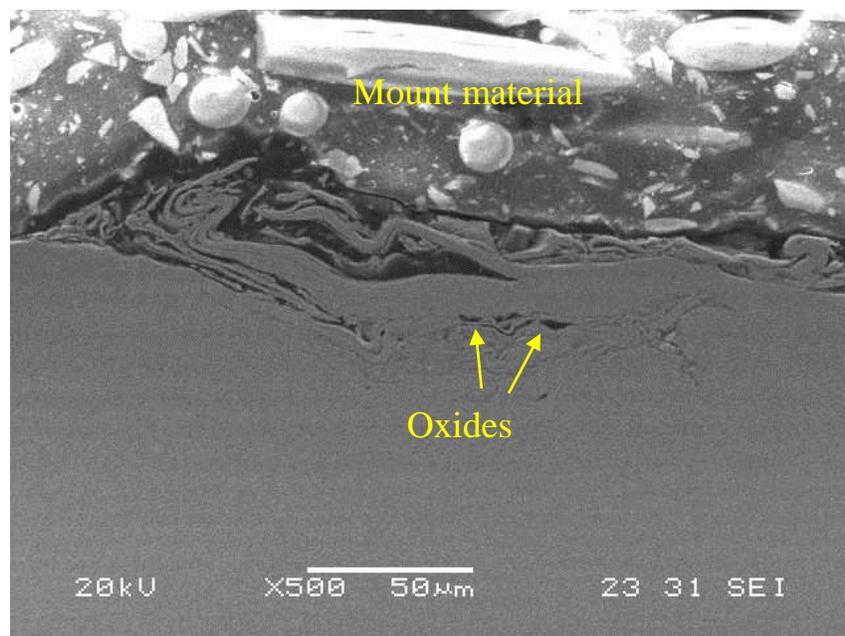
Figure 3: Selected SEM images of the surface of sample “2” black mill scale steel Q235B (5”x2”) illustrating embedded oxide particles.

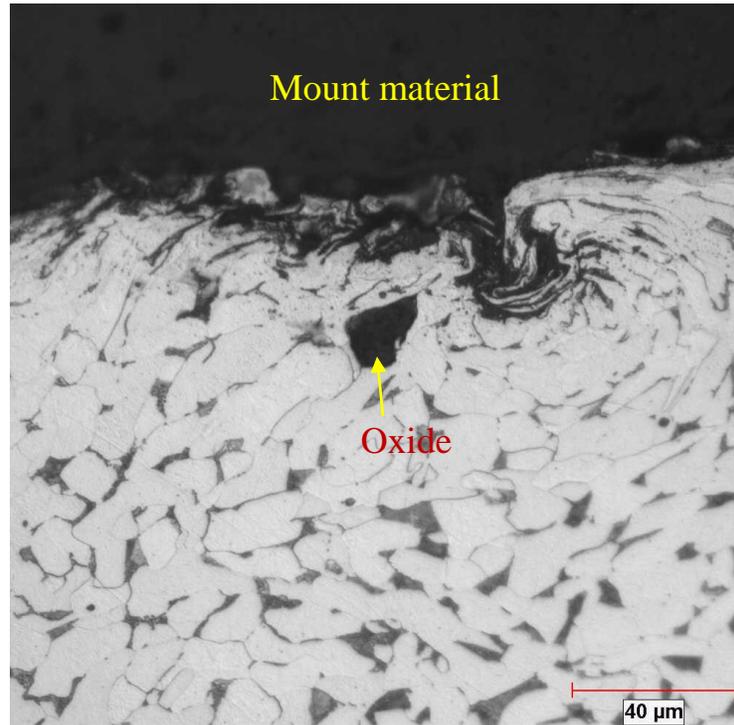
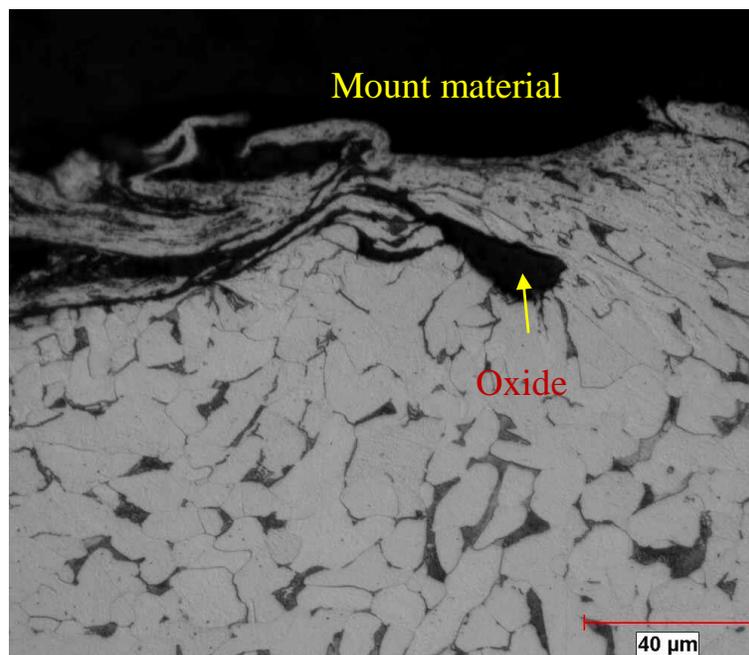
Figure 4: Optical micrographs showing the microstructure of sample “2”, black mill scale steel Q235B (5”x2”) at the surface. Embedded oxides are noted (arrows). The microstructure was composed of ferrite (light) and pearlite (dark). The grains appeared deformed at the surface (etched with 3% Nital, original magnification: 500X).

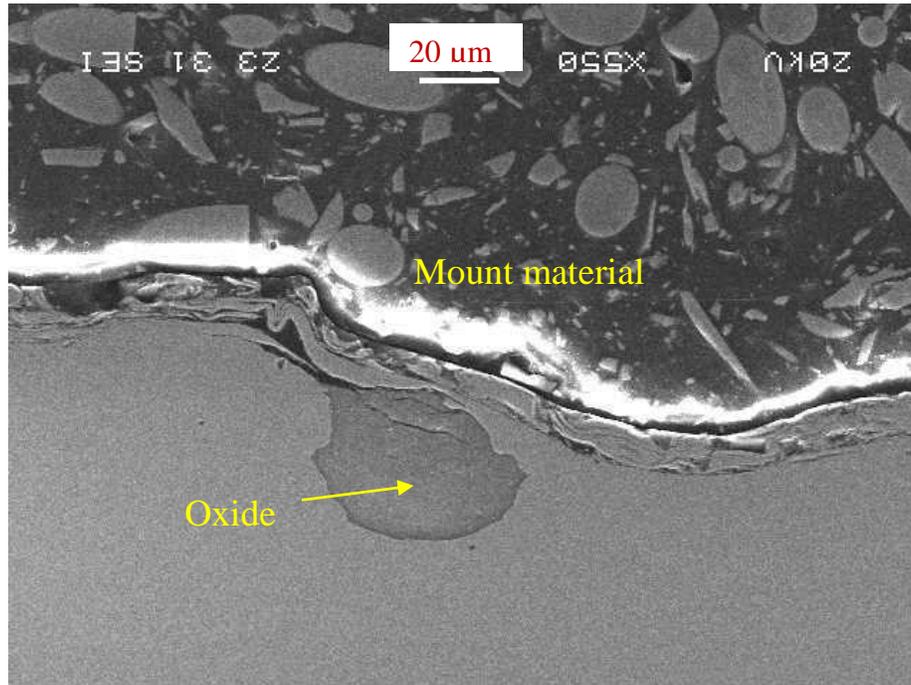
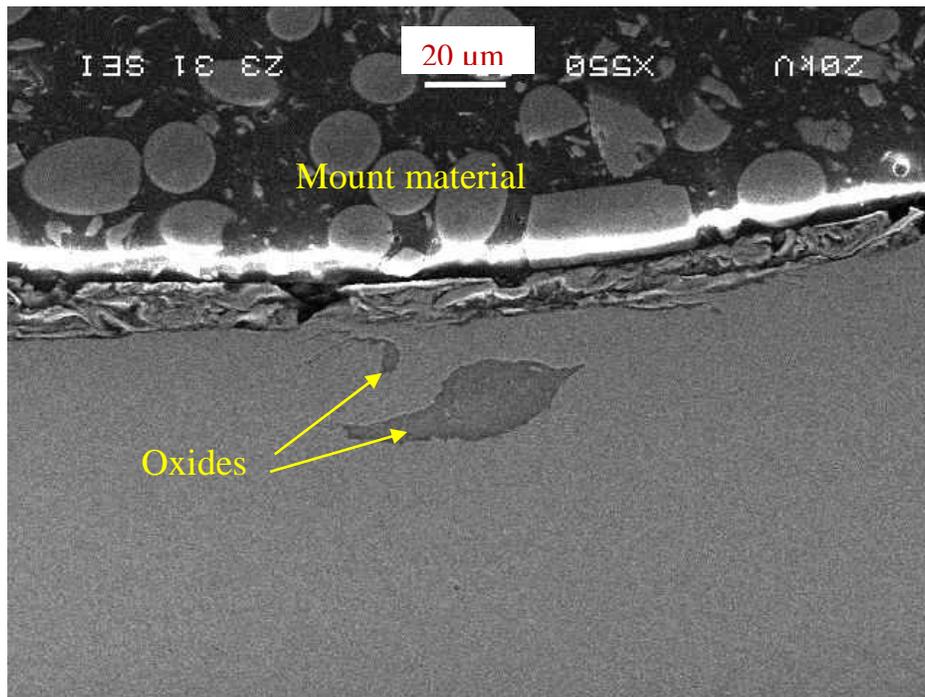
Figure 5: Selected SEM images of the surface of sample “3”, black mill scale steel Q235B (5”x2”) illustrating embedded oxide particles.

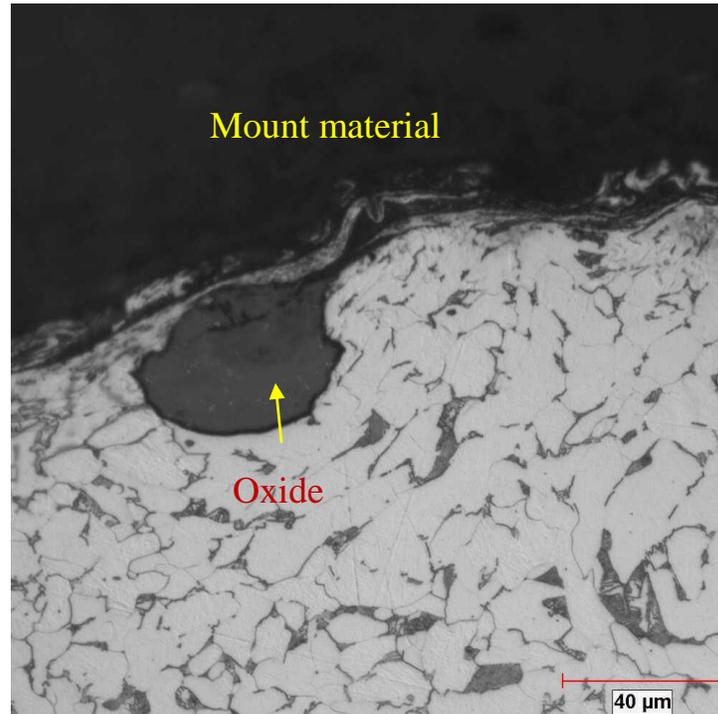
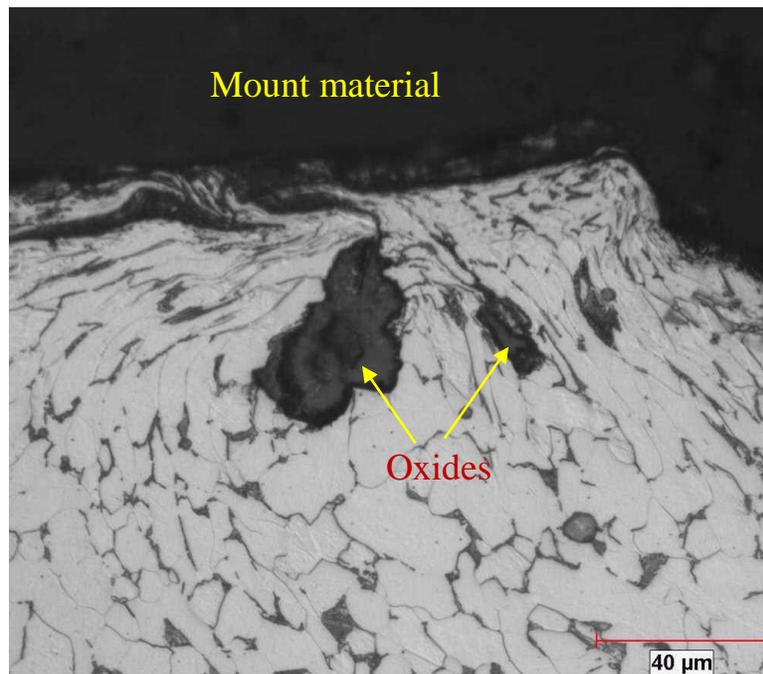
Figure 6: Optical micrographs showing the microstructure of sample “3”, black mill scale steel Q235B (5”x2”) at the surface. Embedded oxides are noted (arrows). The microstructure was composed of ferrite (light) and pearlite (dark). The grains appeared deformed at the surface (etched with 3% Nital, original magnification: 500X).

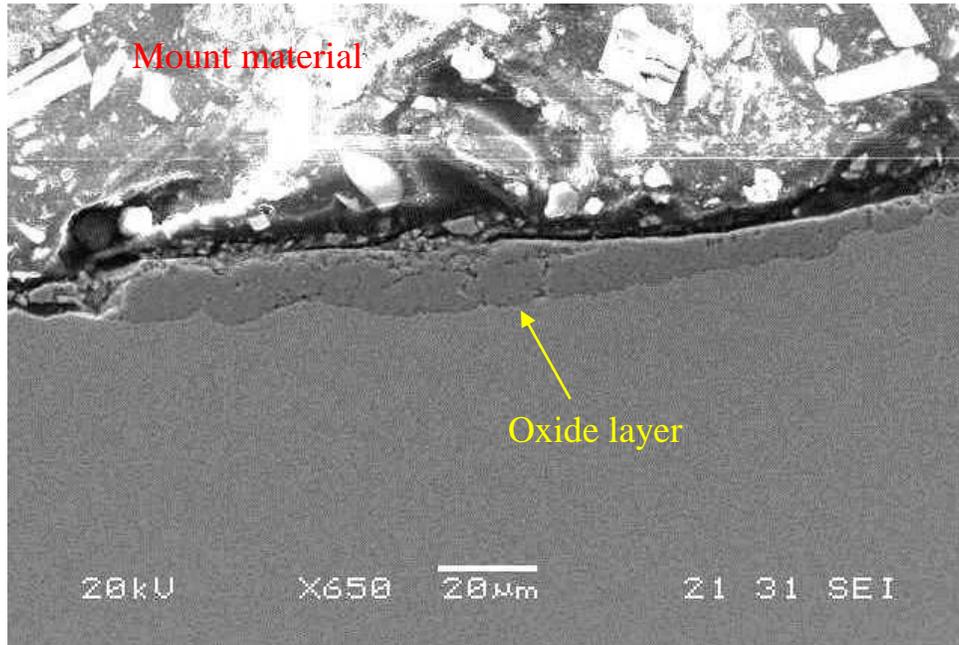
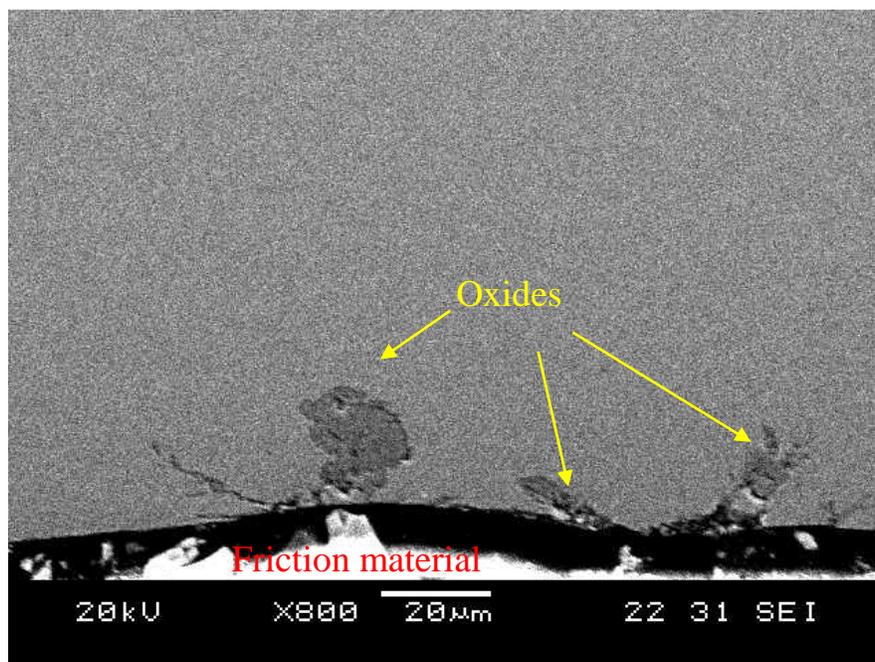
Figure 17: Selected SEM images of the surface of sample “8”, D833 (suspected black mill scale steel). The top image shows the presence of an oxide layer at the hole’s bottom surface. Embedded oxide particles were observed at the interface with the friction material (bottom).

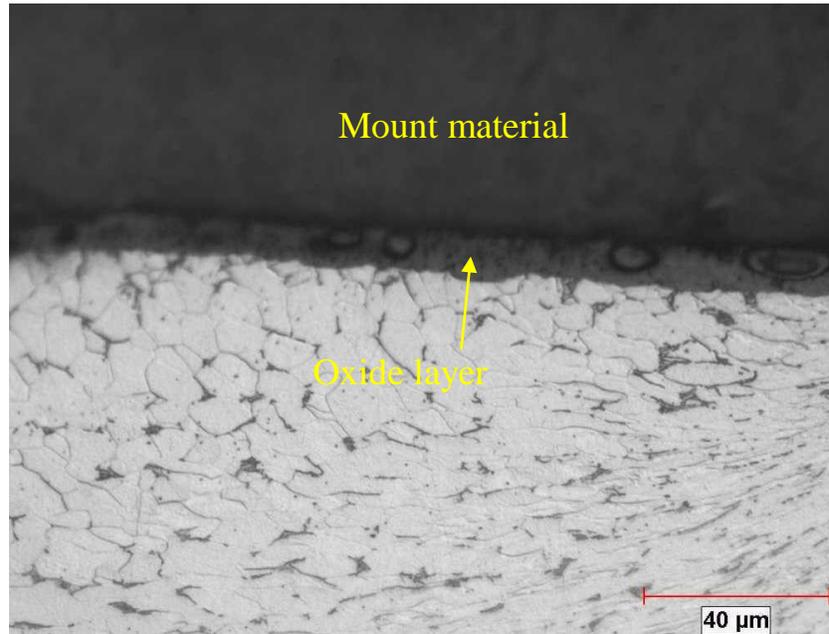
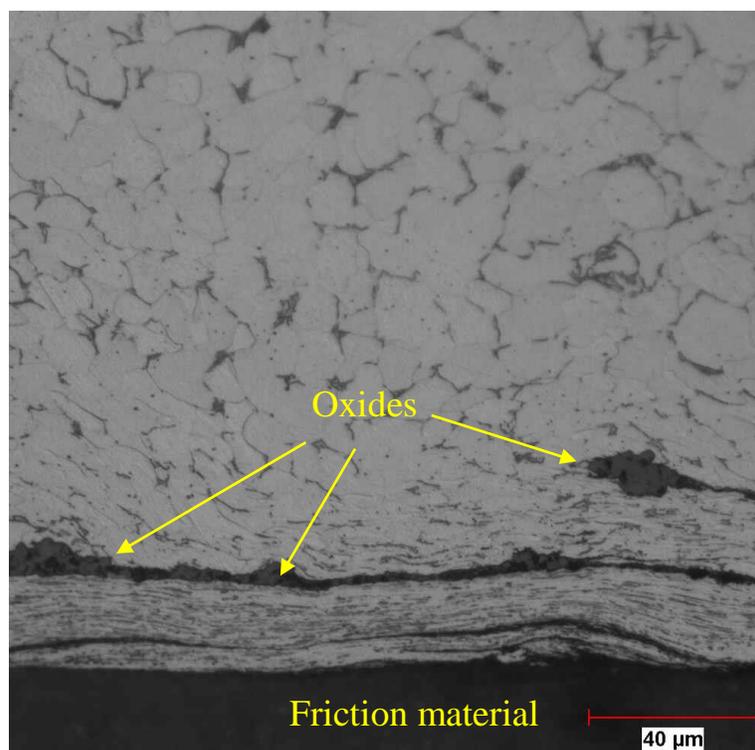
Figure 18: Optical micrographs showing the microstructure at the surface of sample "8", D833 (suspected black mill scale steel). The top images illustrates the oxide layer. The bottom image shows embedded oxides and a deformed microstructure. The microstructure was composed of ferrite (light) and pearlite (dark) (etched with 3% Nital, original magnification: 500X).

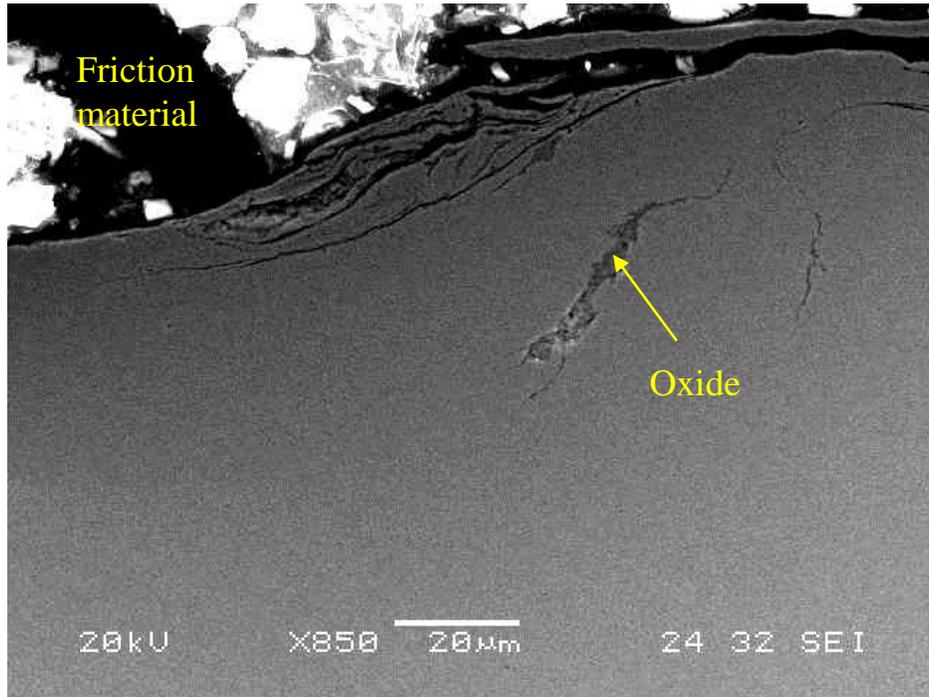
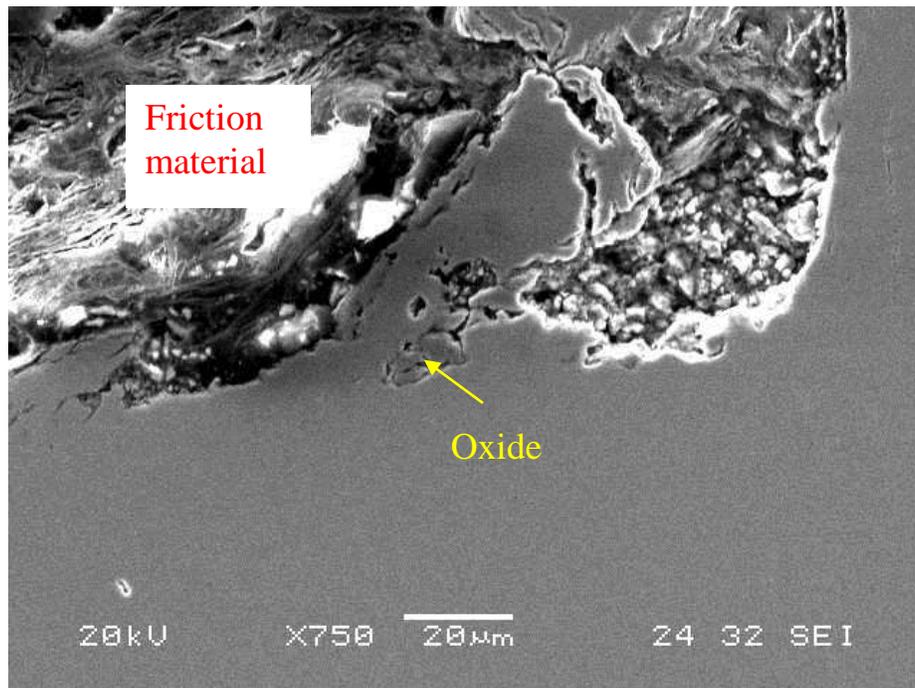
Figure 19: Selected SEM images taken from the surface of sample “8.1”, D833 (suspected black mill scale steel) illustrating isolated embedded oxide particles. The bottom image was taken from the hole at the lug location.

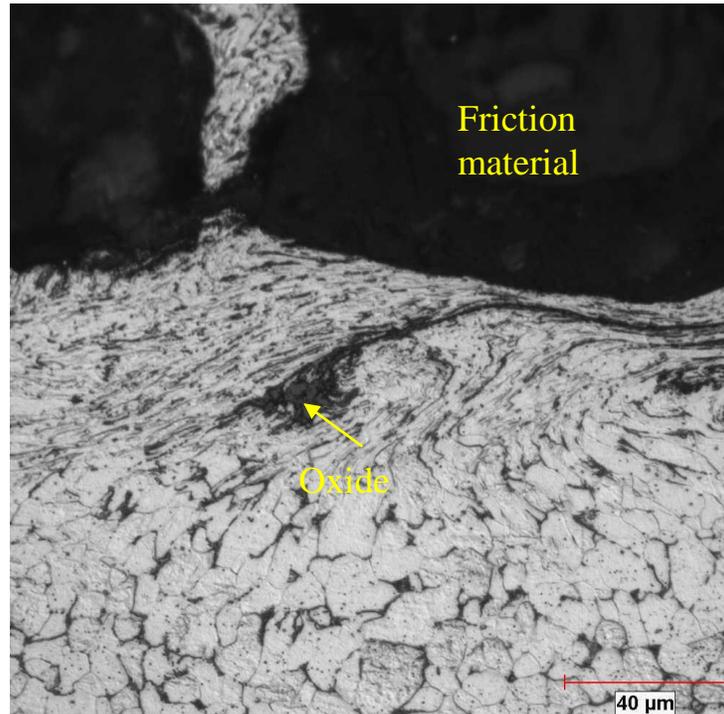
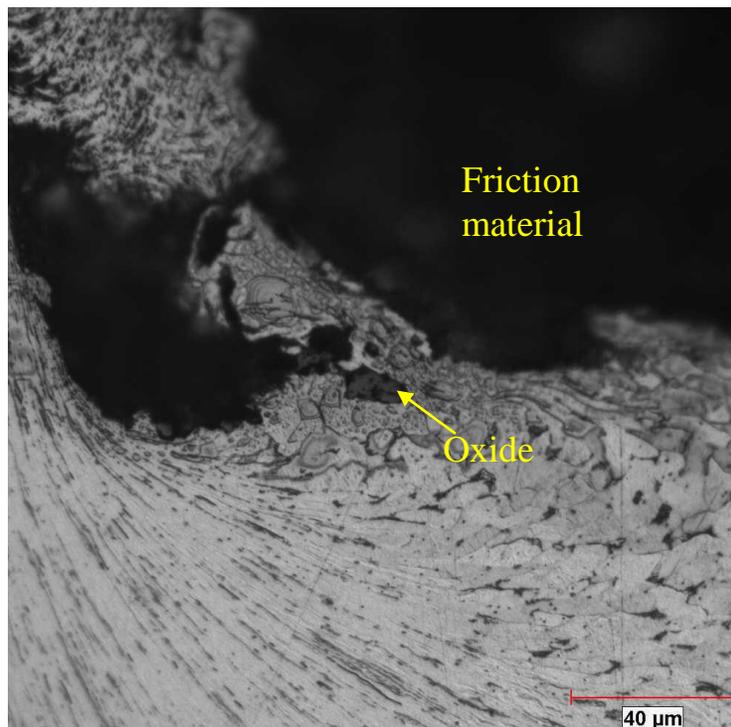
Figure 20: Optical micrographs showing the microstructure at the surface of sample “8.1”, D833 (suspected black mill scale steel). The images presented illustrate the presence of oxide particles observed. The bottom image was taken from the hole at the lug location. The microstructure was composed of ferrite (light) and pearlite (dark). A deformed microstructure is noted at the surface (etched with 3% Nital, original magnification: 500X).

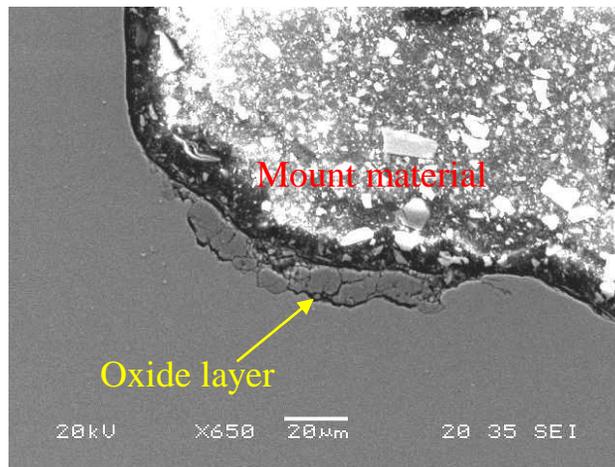
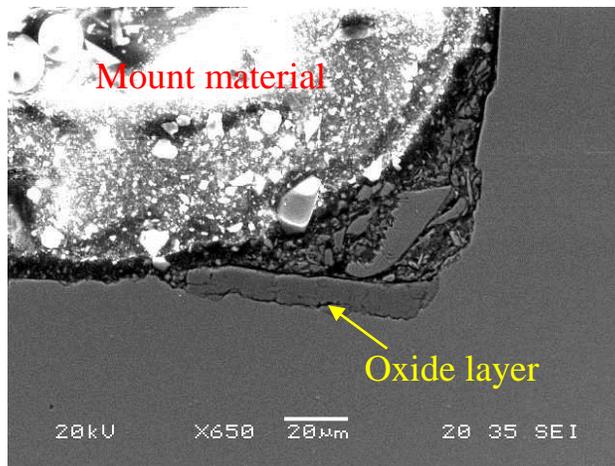
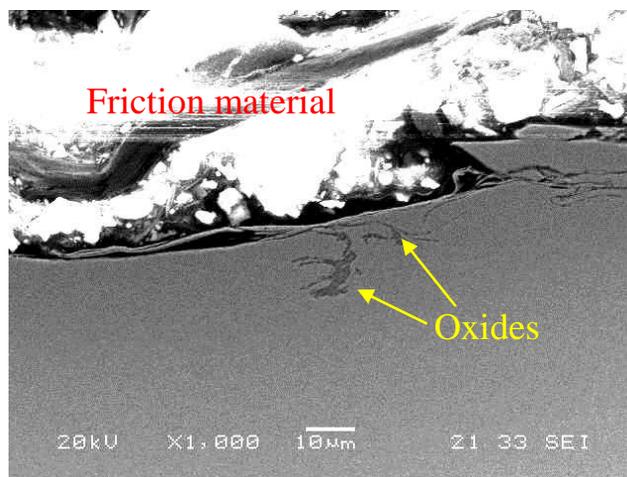
Figure 21: Selected SEM images taken from the surface of sample “9”, D833 (suspected black “mill scale” steel). The top and middle images show an oxide layer at the corners of the blind hole. The bottom image depicts embedded oxide particles.

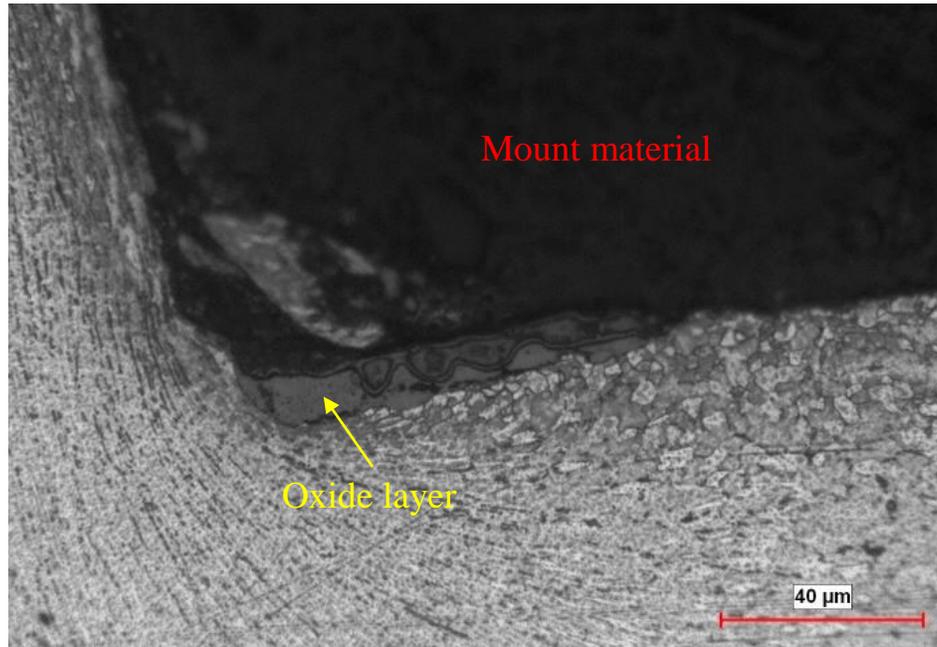
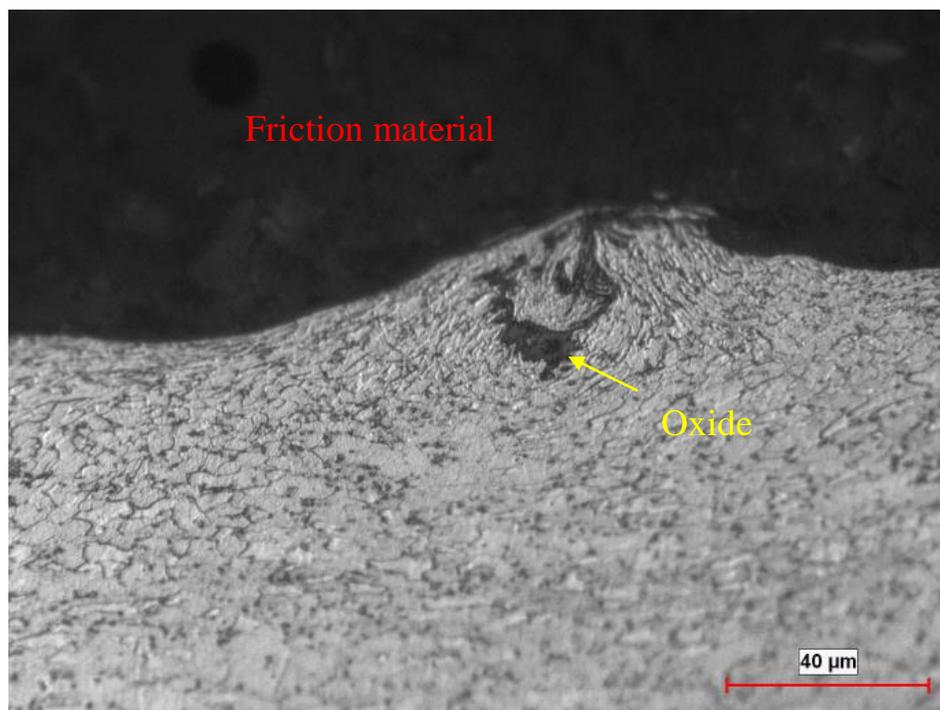
Figure 22: Optical micrographs illustrating the microstructure at the surface of sample “9”, D833 (suspected black mill scale steel). The top image shows the oxide layer at the hole’s corner. The microstructure was deformed at the edges of the hole and at the surface in contact with the friction material. The microstructure was composed of ferrite (light) and pearlite (dark) (etched with 3% Nital, original magnification: 500X).

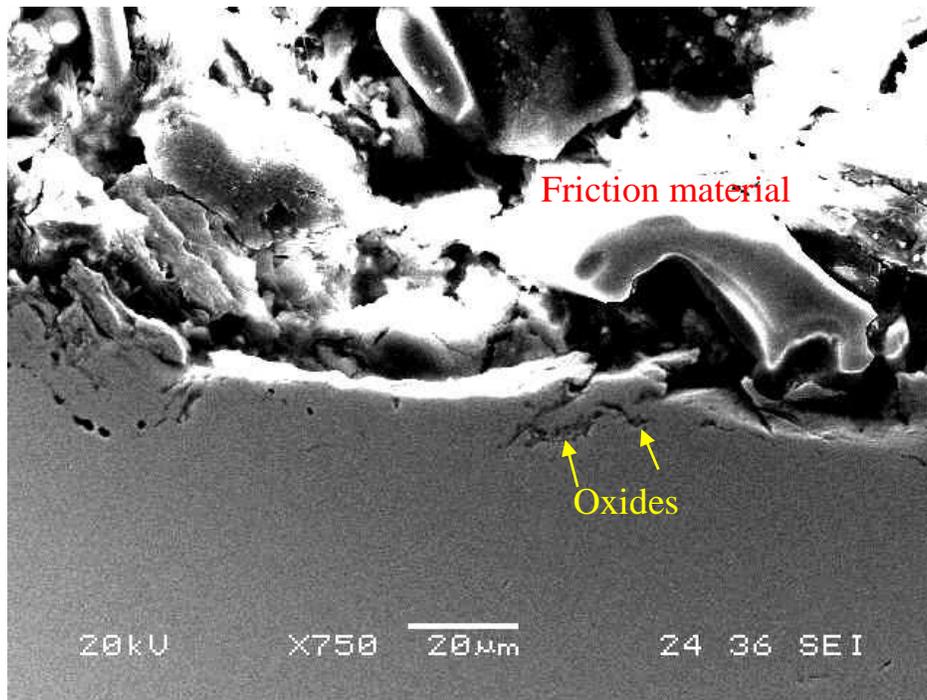
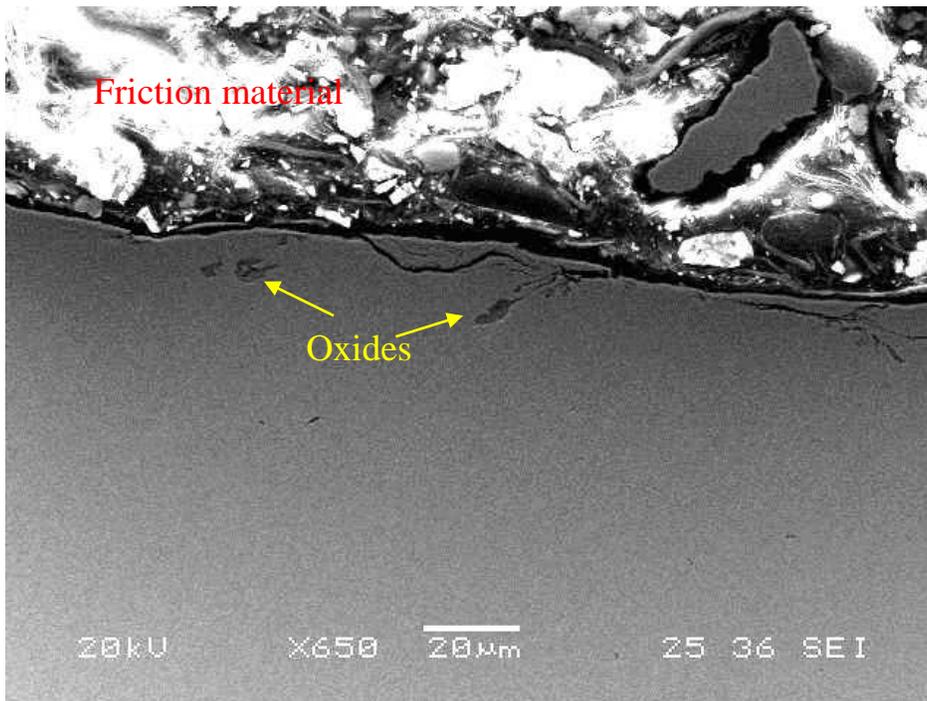
Figure 23: Selected SEM images taken from the surface of sample “9.1”, D833 (suspected black “mill scale” steel). The top image shows oxides inside the hole associated with the lug. The bottom image depicts embedded oxide particles at the interface with the friction material outside the hole.

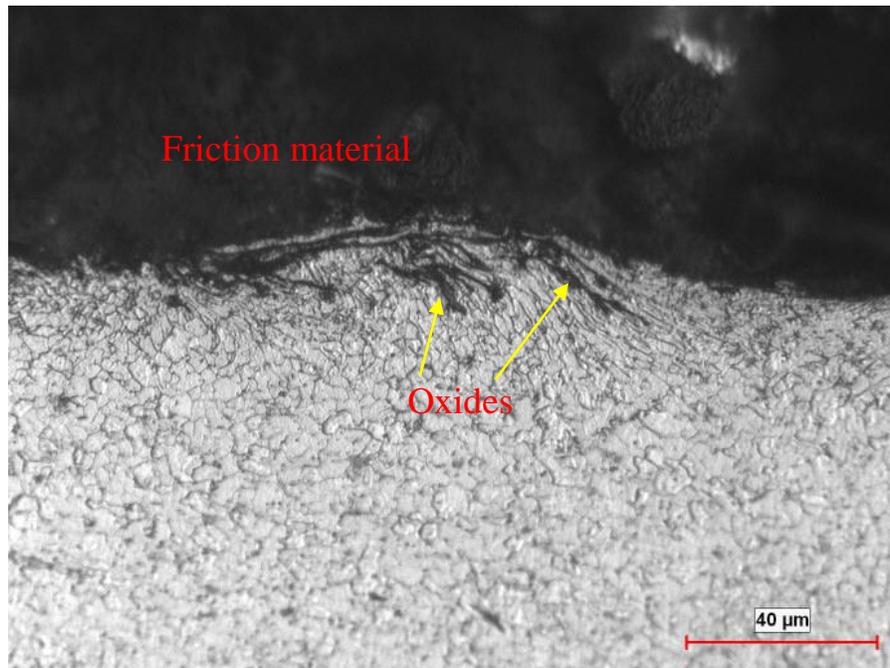
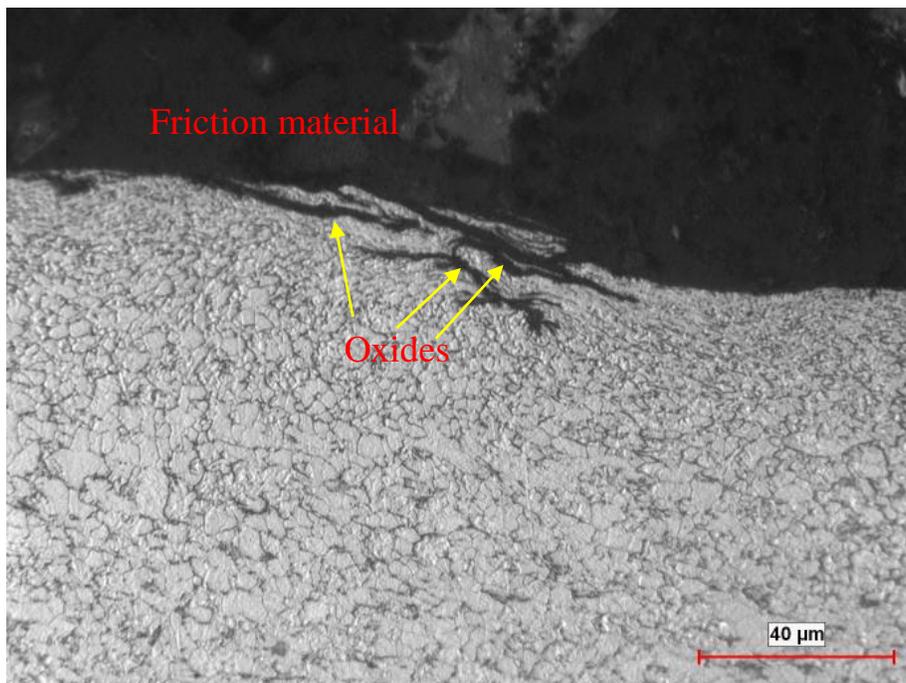
Figure 24: Optical micrographs illustrating the microstructure at the surface of sample “9.1”, D833 (suspected black mill scale steel). The top image was taken from the hole associated with the lug and the bottom image was taken outside the hole. Embedded oxide particles are depicted. The microstructure was composed of ferrite (light) and pearlite (dark). Deformed grains are observed adjacent to the surface (etched with 3% Nital, original magnification: 500X).

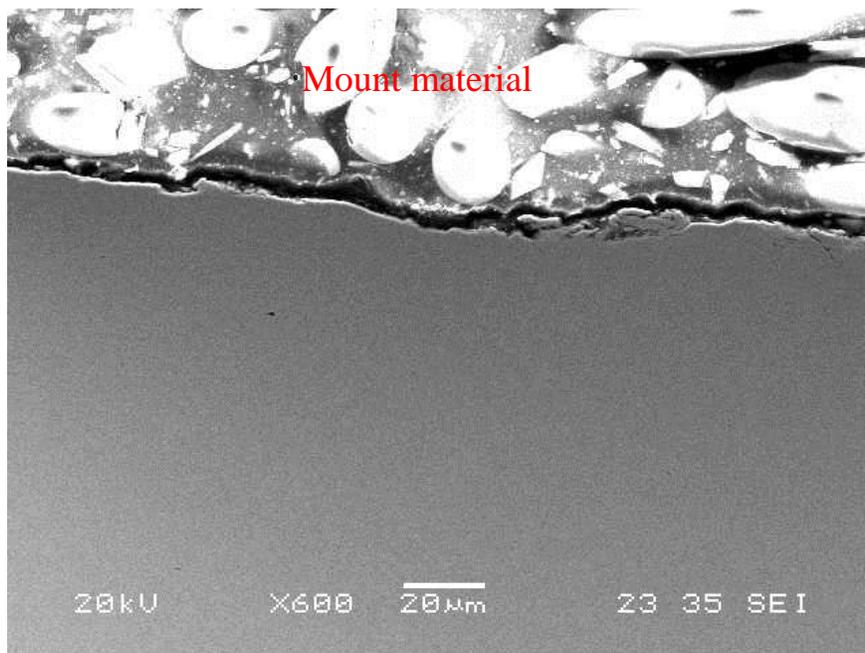
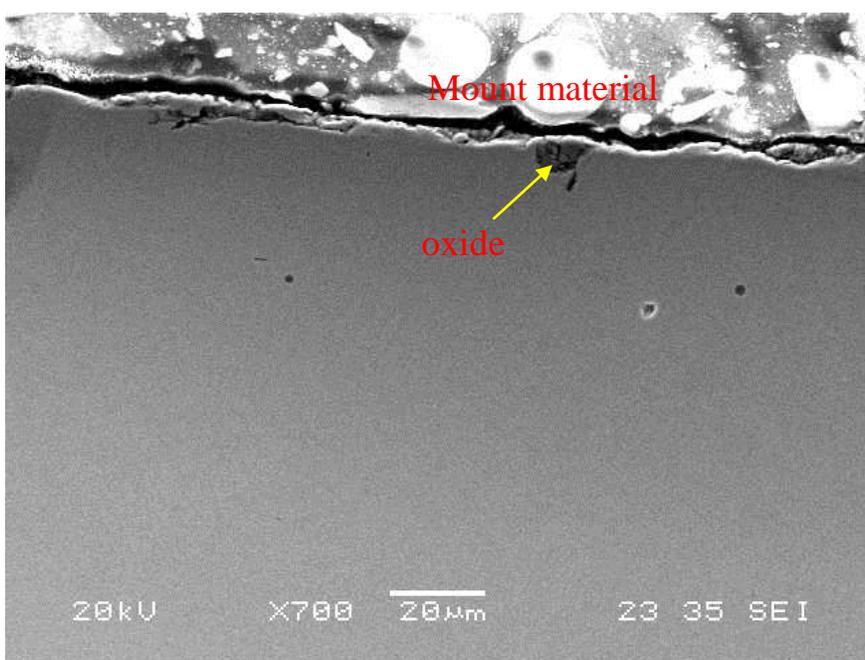
Figure 25: Selected SEM images taken from the surface of sample “10”, D1282 (suspected black “mill scale” steel). Few isolated oxide particles rich in iron and aluminum were detected (bottom image).
