EFFECTS OF 'BLACK STEEL' AND ITS CONTRIBUTION TO PREMATURE BRAKE PAD REPLACEMENT AND BRAKE PAD FAILURE

Abstract

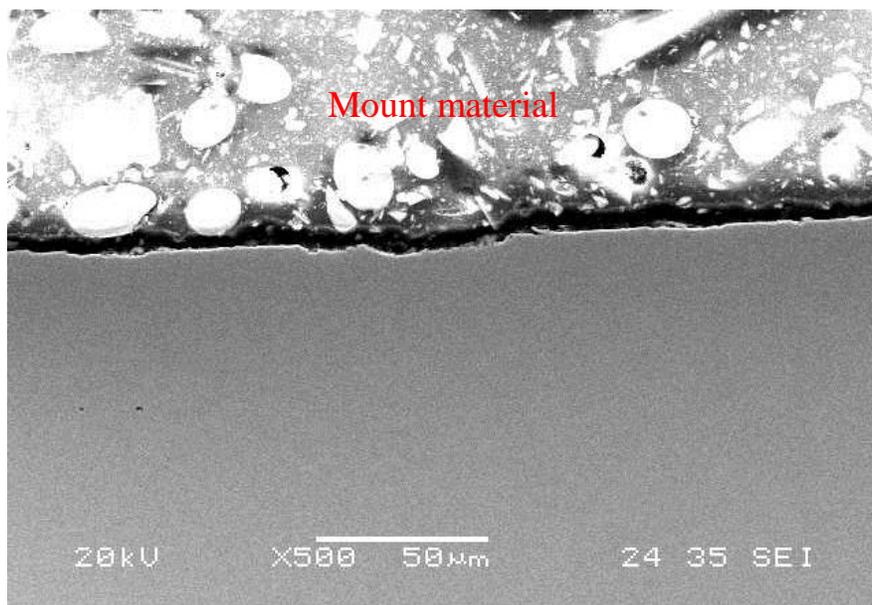
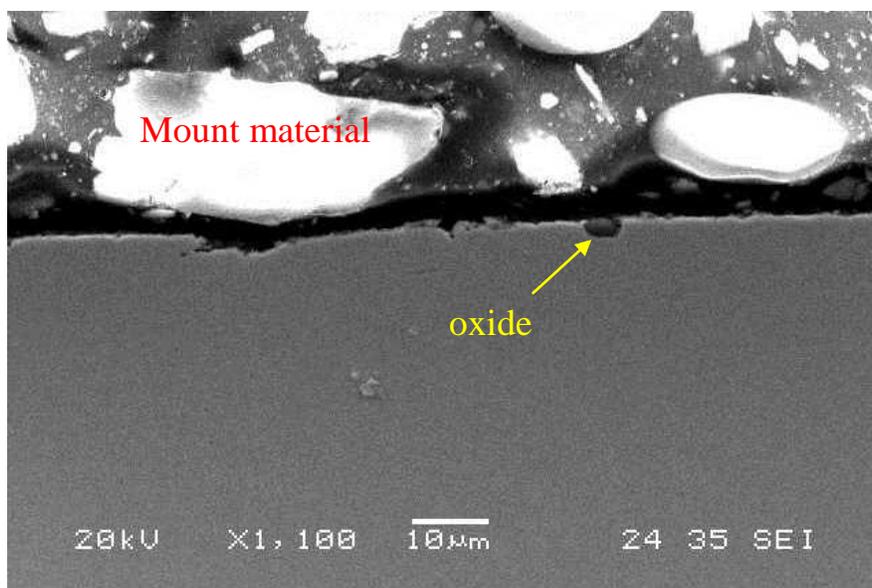
Figure 27: Selected SEM images taken from the surface of sample “11”, D1283 (suspected black “mill scale” steel). Few isolated oxide particles rich in iron and aluminum were detected (bottom image).
