SAFETY ALERT

Bulletin No. 05.06.16

Delaminated Disc Brake Pads are not worn out; they are broken.

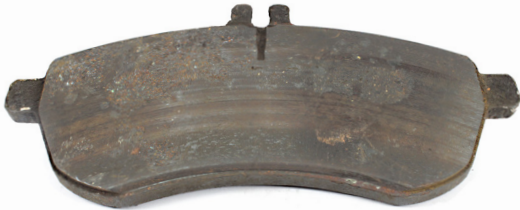
WORN OUT

Both field and laboratory test results repeatedly prove that the friction lining on a disc brake pad can wear to within a millimeter of the mating surface of the disc brake shoe without affecting brake function, *provided the entire surface area of the friction lining material remains intact during contact with the rotor.*

In fact, Original Equipment pad wear indicators, designed to warn the motorist that the friction lining needs replacement, typically activate when there is only 1.5mm to 2mm of friction lining remaining.

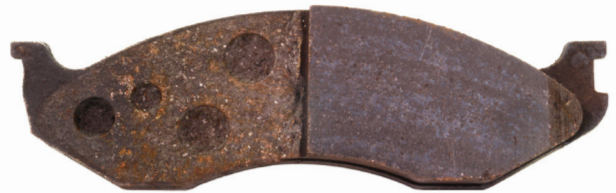
BROKEN

If the friction lining material is not positively and permanently attached to the disc brake shoe, it becomes possible for the friction lining to delaminate. Delamination results in an immediately degraded performance of the braking system. This instantaneous disruption, even if only temporary, can prove lethal in the event of a panic stop.
