SAFETY ALERT

Bulletin No. 05.06.16

Delaminated Disc Brake Pads are not worn out; they are broken.

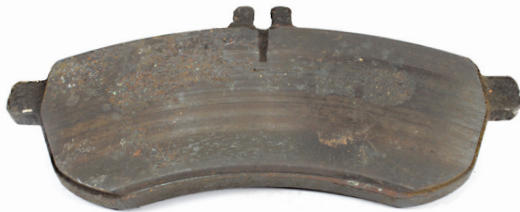
WORN OUT

Both field and laboratory test results repeatedly prove that the friction lining on a disc brake pad can wear to within a millimeter of the mating surface of the disc brake shoe without affecting brake function, *provided the entire surface area of the friction lining material remains intact during contact with the rotor.*

In fact, Original Equipment pad wear indicators, designed to warn the motorist that the friction lining needs replacement, typically activate when there is only 1.5mm to 2mm of friction lining remaining.

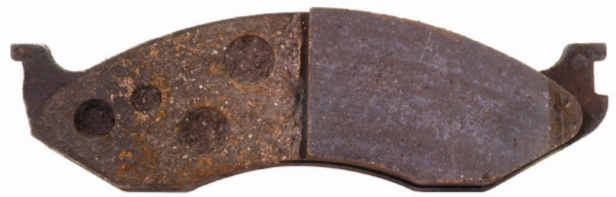
BROKEN

If the friction lining material is not positively and permanently attached to the disc brake shoe, it becomes possible for the friction lining to delaminate. Delamination results in an immediately degraded performance of the braking system. This instantaneous disruption, even if only temporary, can prove lethal in the event of a panic stop.

If the friction lining material suddenly breaks away from a disc brake pad, even partially, the pistons pushing on that disc brake pad will instantly have an increased void that it must push past to reach a level of pressure that stops the vehicle. This sudden void destabilizes the system, increasing the brake pedal travel needed to make the vehicle come to a stop. In order to build the brake system's pressure back up, the driver must "pump" the brake pedal. Depending on circumstances in panic situations, the driver may not have the time to build up enough pressure to re-activate the brakes.

The delamination of friction lining material can also lead to excessive heat transfer through the compromised disc brake pad and into the brake caliper, causing the brake system's hydraulic fluid to boil. Once the fluid is beyond safe operating temperatures, gases begin to form in the fluid, preventing the system from generating any pressure. Effectively, the brake system is no longer functional.

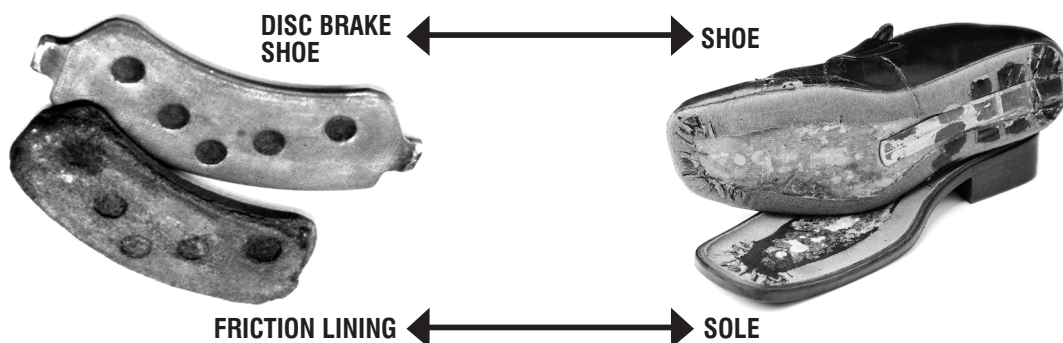
Not many motorists understand how disc brake pads are constructed. They would not consider a disc brake pad to be an assembly of a steel disc brake shoe and friction lining, if they considered it at all. Similar to how the sole is attached to a person's shoe, a disc brake pad's functionality depends on the permanent attachment of these two individual components. Normally, the sole of a person's shoe wears gradually, providing a constant level of support to the wearer. If any or all of the sole falls away the shoe becomes unstable, and even dangerous, if the wearer is mid-step when the failure occurs, just like brakes.
