ENGINEERING BULLETIN

Bulletin No. 12.14.17

Brake Pad Failure Modes and their Consequences

EFFECTIVE - DECEMBER 14, 2017

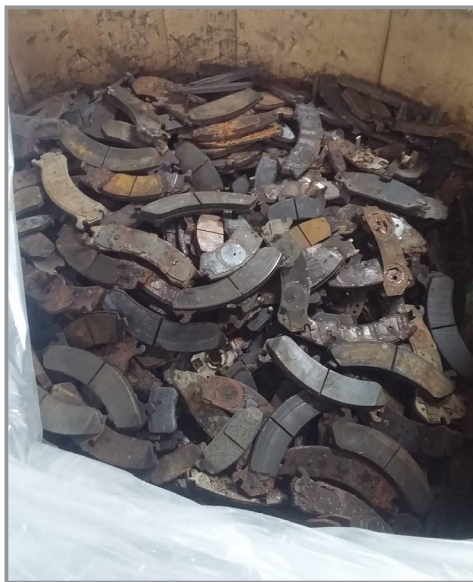
FIG. 1
AS-RECEIVED BRAKE PADS

The collection of the replaced brake pads across months – and numbering more than 3200 parts– was designed to include the impact of the four seasons. The brake pads were received in crates on wooden skids at Nucap's R&D Lab in Toronto, Canada (Fig. 1).

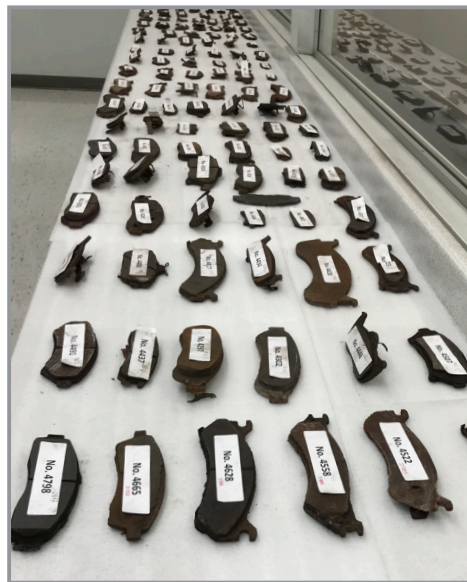
FIG. 2
TAGGED AS-RECEIVED BRAKE PADS

Each As-received Brake Pad was catalogued, tagged with a number designation, photo-documented, and visually inspected (Fig. 2).

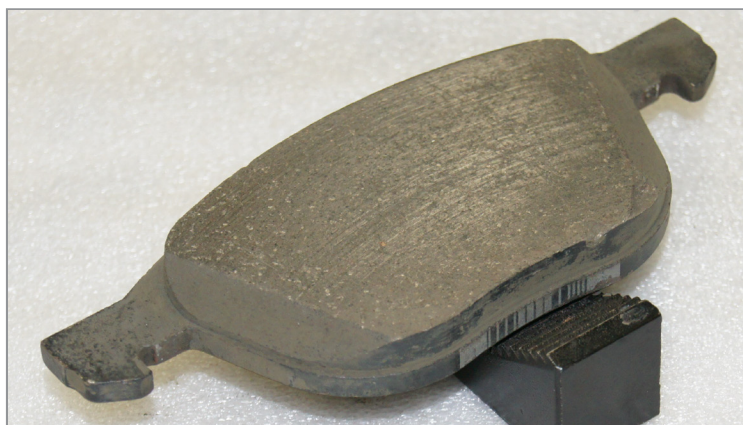
FIG. 3

i) No apparent visible cause for replacement (Fig.3)

- **Noted in 66.9% of the cases**
- The majority of these brake pads showed more than 50% of friction life remaining with no visible delamination or separation

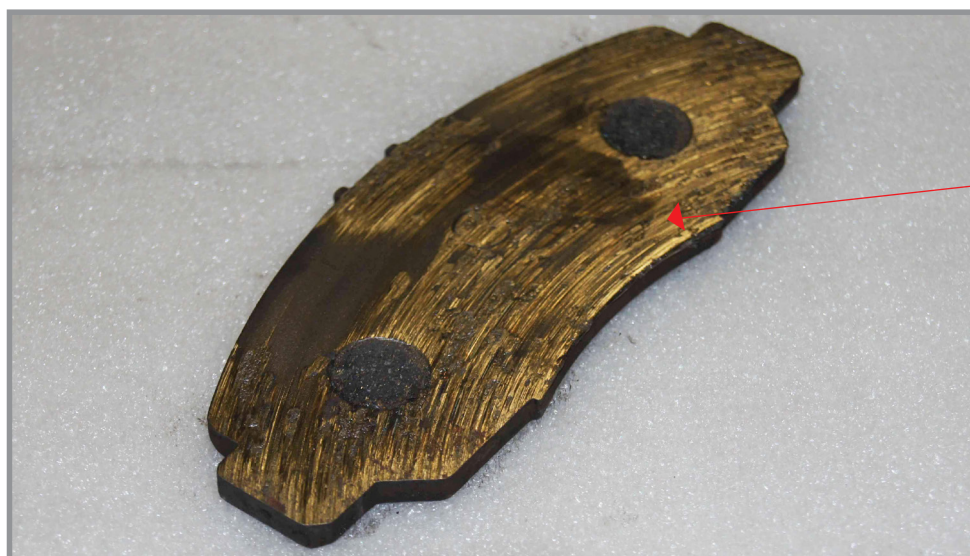
Back plate after
rotor contact

FIG. 4
FRICTION WORN TO BACK-PLATE

- **Noted in 5.6% of the cases (or 179 cases)**
- Complete wear-out to back-plate; evidence of galling
- **Consequence: Noise; rotor damage requiring replacement**

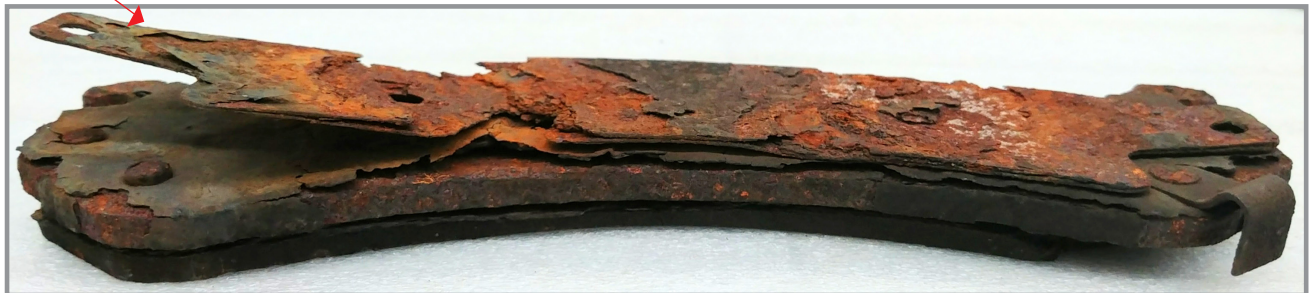
Delaminated shim

FIG. 5
EXCESSIVE RUST

- Noted in 11.0% of the cases (or 352 cases)
- Shim de-bonded; pad abutments and clips corroded
- **Consequence:** Noise; drag, leading to early wear-out and increased fuel consumption; **possible shim migration leading to cut brake rotor (a tangible safety risk)**

11.0% of the cases for excessive rust (352 out of 3200 cases)

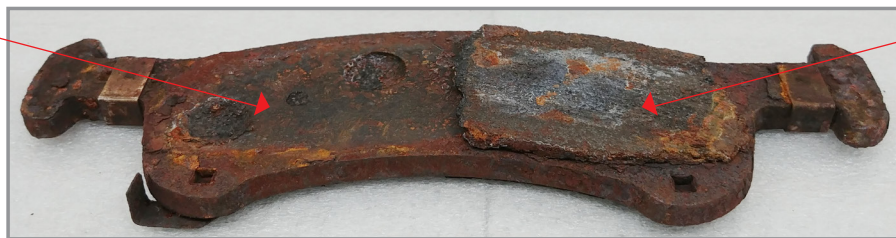
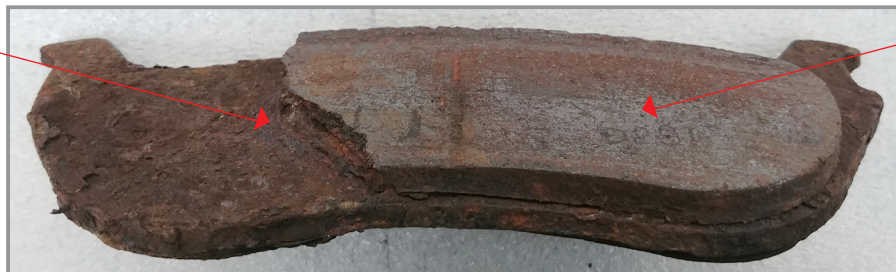
Broken/Separated
friction lining

Remaining friction lining
showing wear level
of brake pad

FIG. 7
BROKEN/SEPARATED FRICTION

- **Noted in 5.3% of the cases (or 170 cases)**
- Substantial part of friction separated from pad/ back plate.
- **Consequence: partial or full friction separation from the back-plate, leading to loss of braking power and vehicle braking instability (a tangible safety risk).**

5.3% for Broken Friction (170 out of 3200 cases)
