EFFECTS OF 'BLACK STEEL' AND ITS CONTRIBUTION TO PREMATURE BRAKE PAD REPLACEMENT AND BRAKE PAD FAILURE

Abstract

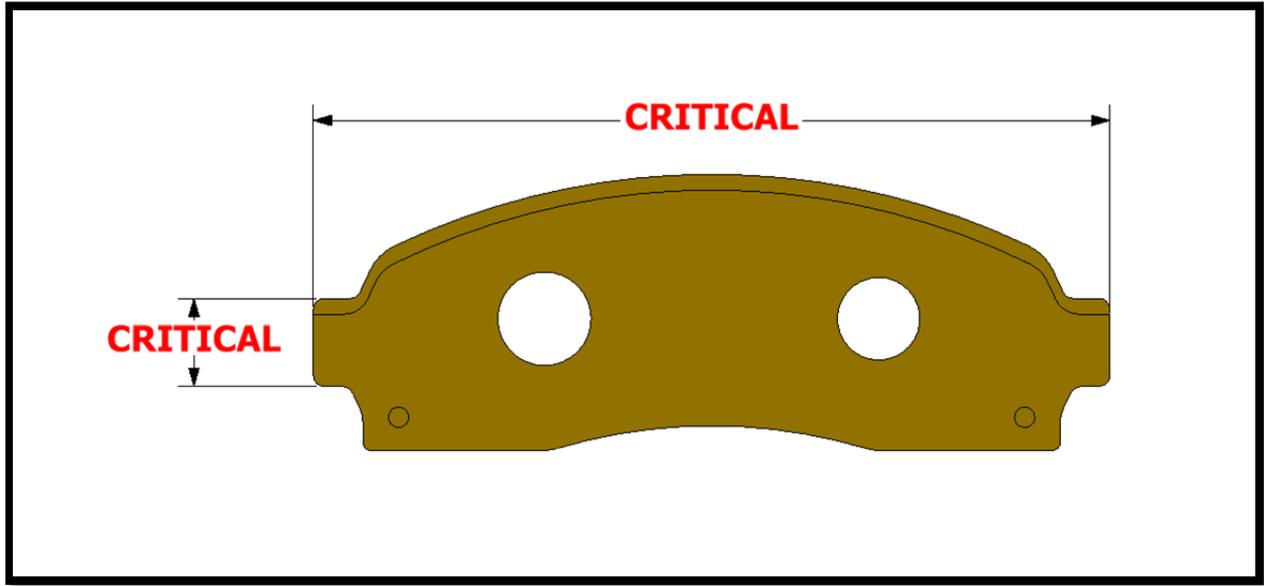
Figure 1 - Critical dimension representation

It is an essential requirement in the automotive industry that the disc brake shoe profile be designed with respect to the brake caliper. In order for a disc brake shoe to function safely, a set of critical dimensions are defined. Critical dimensions differ from one design to another. As shown in Table 2, D833 has three (3) critical dimensions; the two (2) abutment dimensions shown below in Figure 1 and the disc brake shoe flatness in Table 2.

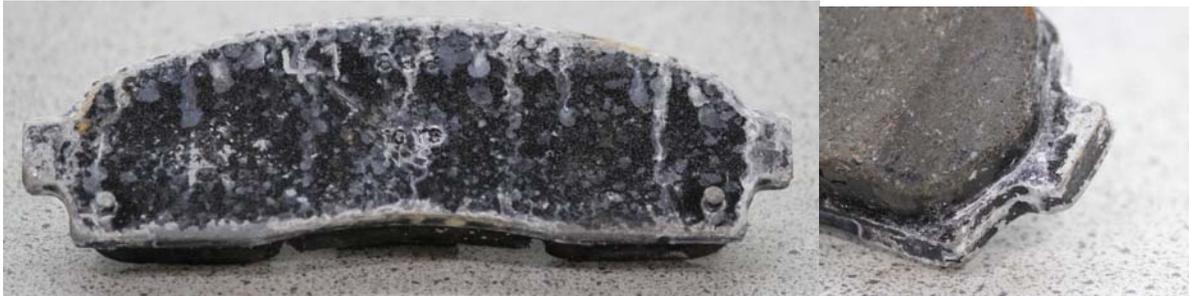
Figure 9 - Sample 4.1 - Premium grade using zinc coated disc brake shoe (20 Hours)

Sample 4.1: Premium grade using zinc coated disc brake shoe (See Figure 9):

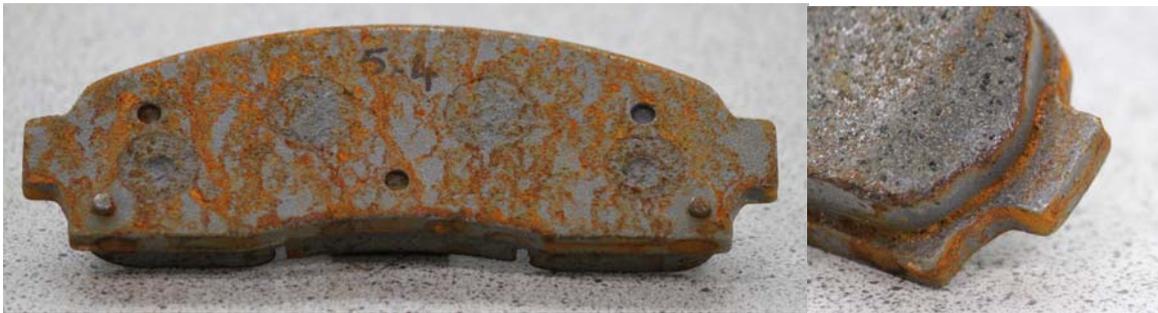
Figure 10 - Sample 5.4 - Mid grade-1 (20 Hours)

Sample 5.4: Mid grade-1 (See Figure 10):

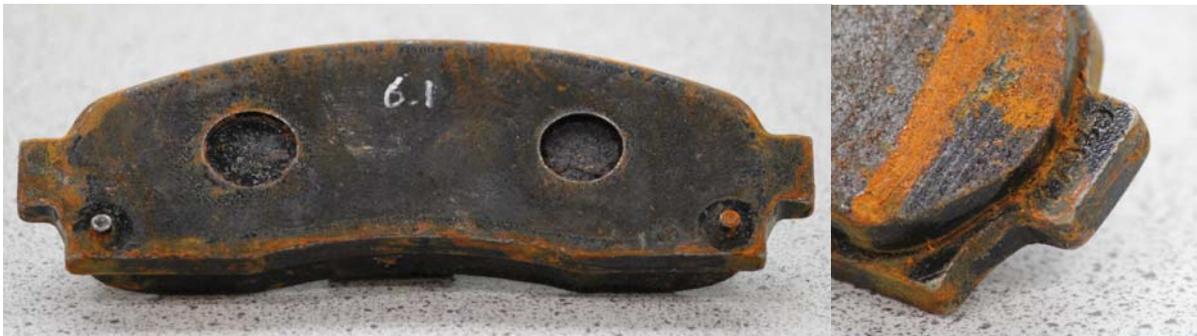
Figure 11 - Sample 6.1 - OES (20 Hours)

Sample 6.1: OES (See Figure 11):

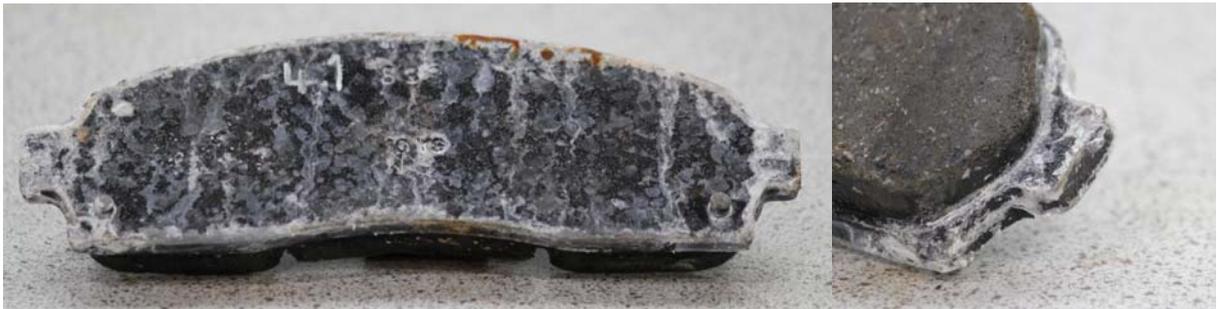
Figure 13 - Sample 4.1 - Premium grade using zinc coated disc brake shoe (40 Hours)

Sample 4.1: Premium grade using zinc coated disc brake shoe (See Figure 13):

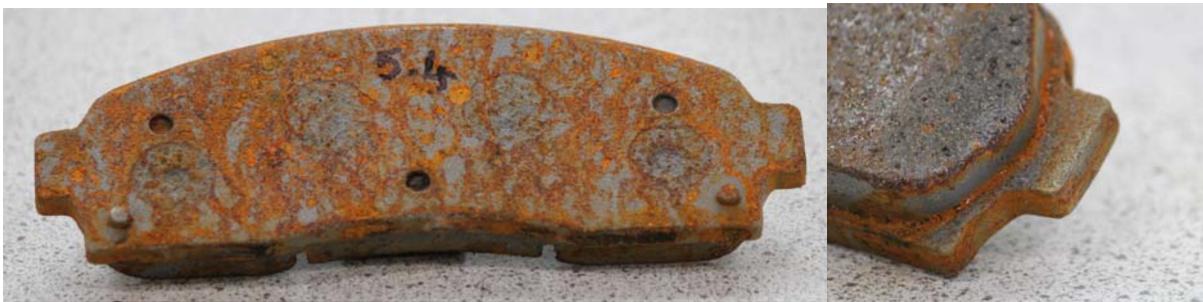
Figure 14 - Sample 5.4 - Mid grade-1 (40 Hours)

Sample 5.4: Mid grade-1 (See Figure 14):

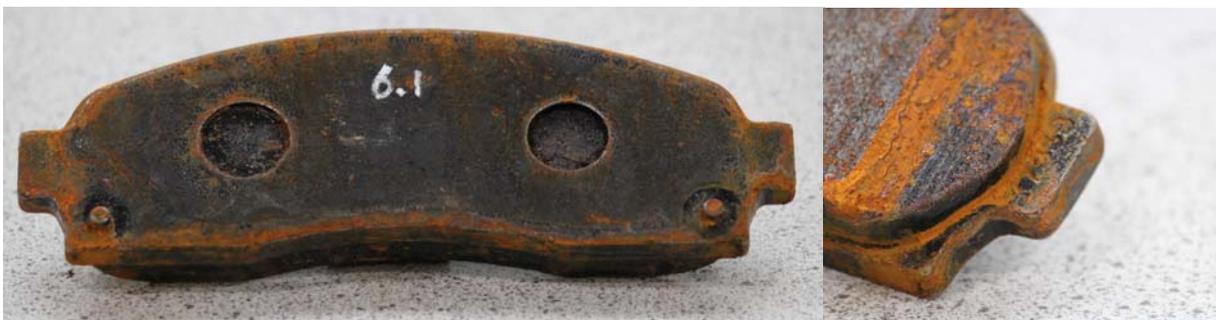
Figure 15 - Sample 6.1 - OES (40 Hours)

Sample 6.1: OES (See Figure 15):

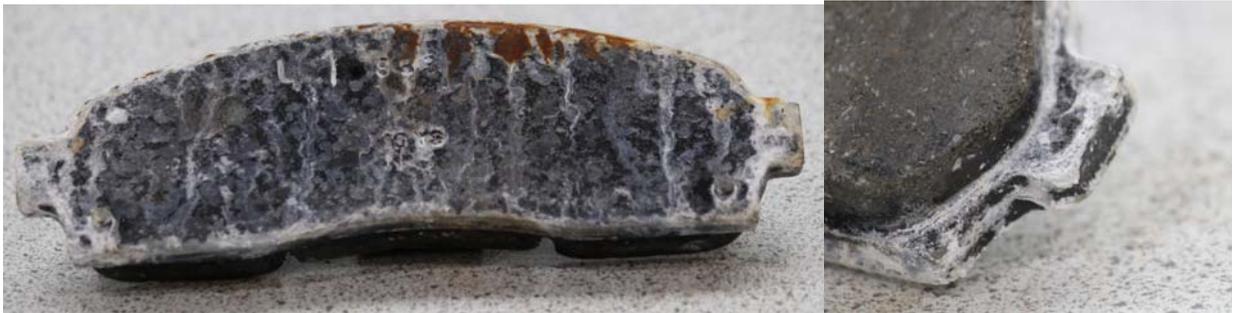
Figure 17 - Sample 4.1 - Premium grade using zinc coated disc brake shoe (60 Hours)

Sample 4.1: Premium grade using zinc coated disc brake shoe (See Figure 17):

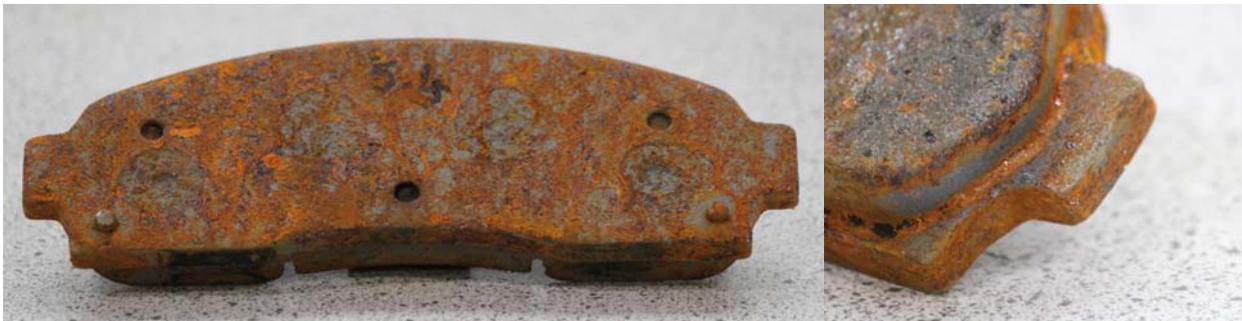
Figure 18 - Sample 5.4 - Mid grade-1 (60 Hours)

Sample 5.4: Mid grade-1 (See Figure 18):

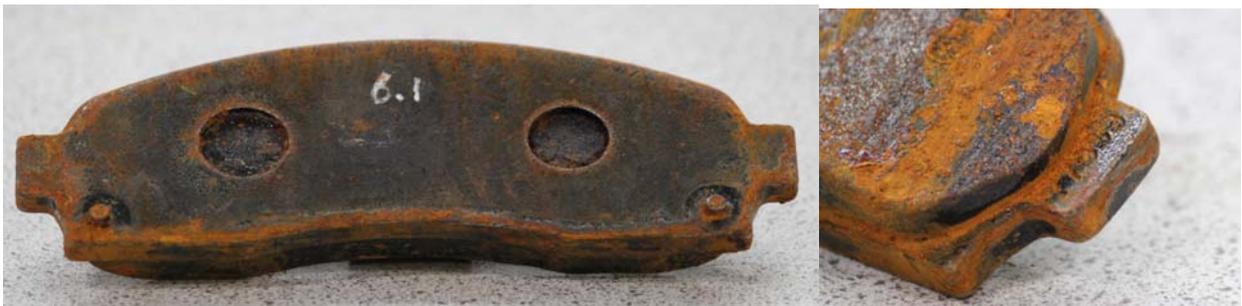
Figure 19 - Sample 6.1 - OES (60 Hours)

Sample 6.1: OES (See Figure 19):

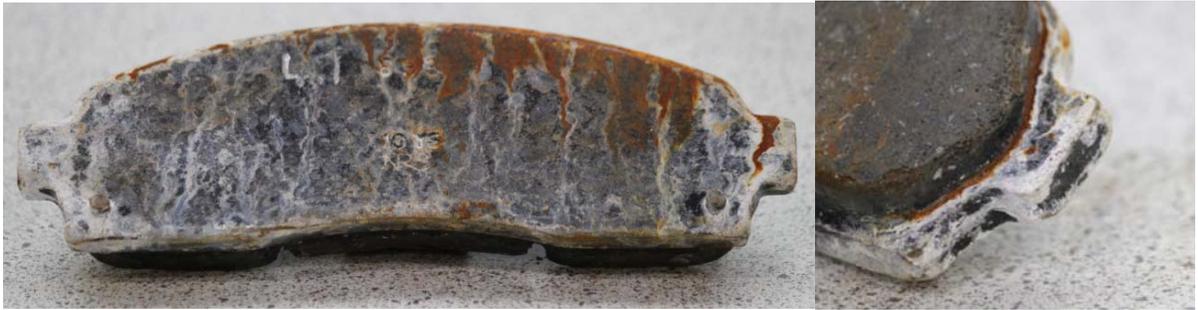
Figure 21 - Sample 4.1 - Premium grade using zinc coated disc brake shoe (80 Hours)

Sample 4.1: Premium grade using zinc coated disc brake shoe (See Figure 21):

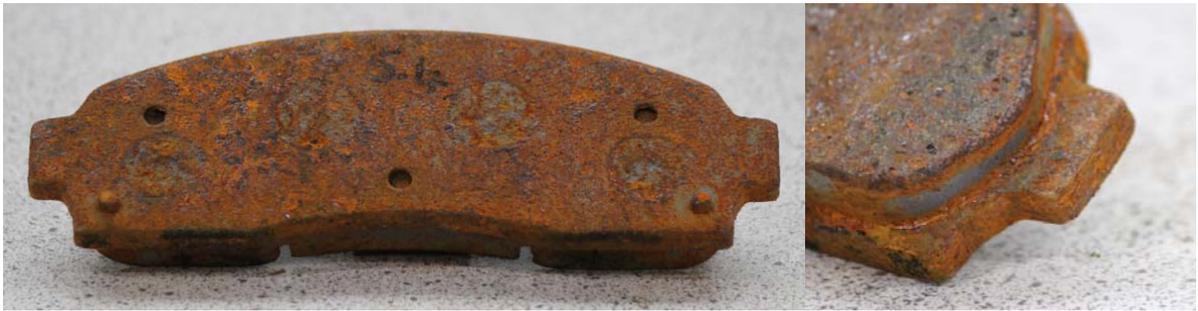
Figure 22 - Sample 5.4 - Mid grade-1 (80 Hours)

Sample 5.4: Mid grade-1 (See Figure 22):

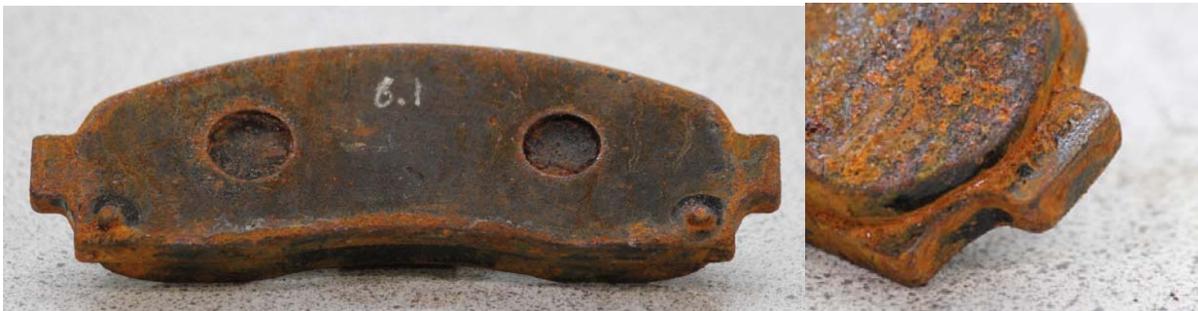
Figure 23 - Sample 6.1 - OES (80 Hours)

Sample 6.1: OES (See Figure 23):

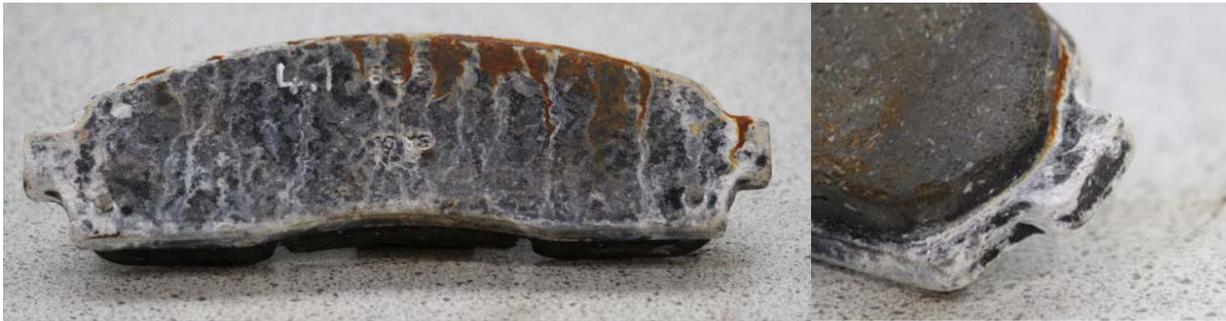
Figure 25 - Sample 4.1 - Premium grade using zinc coated disc brake shoe (96 Hours)

Sample 4.1: Premium grade using zinc coated disc brake shoe (See Figure 25):

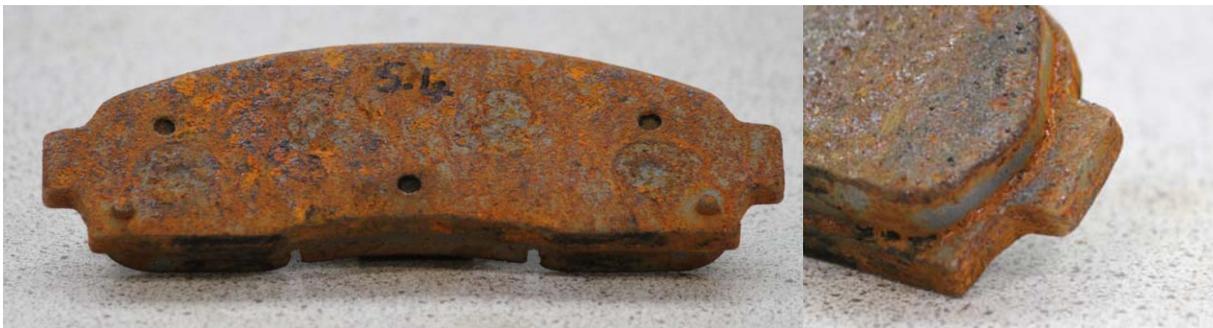
Figure 26 - Sample 5.4 - Mid grade-1 (96 Hours)

Sample 5.4: Mid grade-1 (See Figure 26):

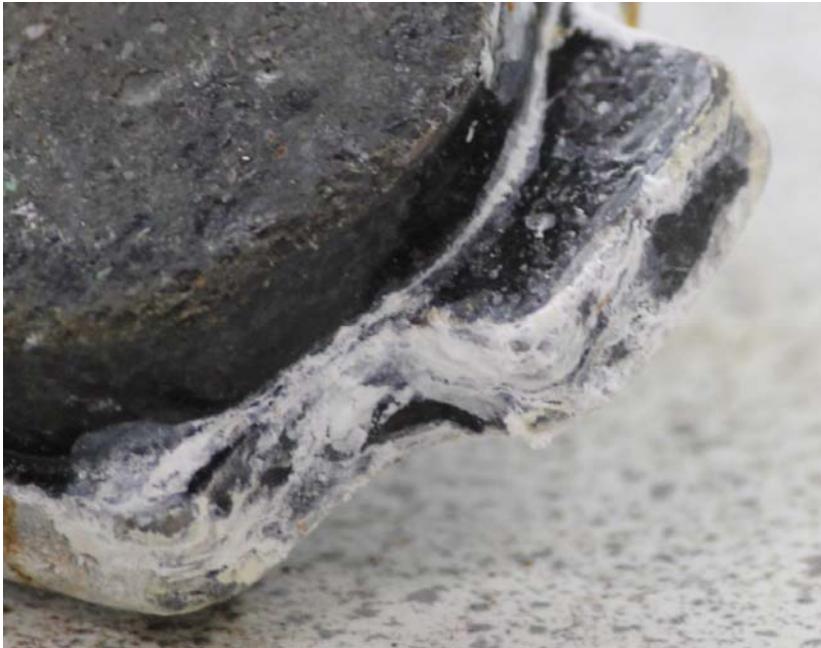
Figure 29 - Pad from sample set 4

- Pads from sample set 4, with paint over zinc coating, showed erratic changes in dimensions, inconsistent with the growth patterns of the other sets. These pads are the only ones recorded that had patterns of dimensional increase followed by a decrease on some of the samples (see Figure 29).

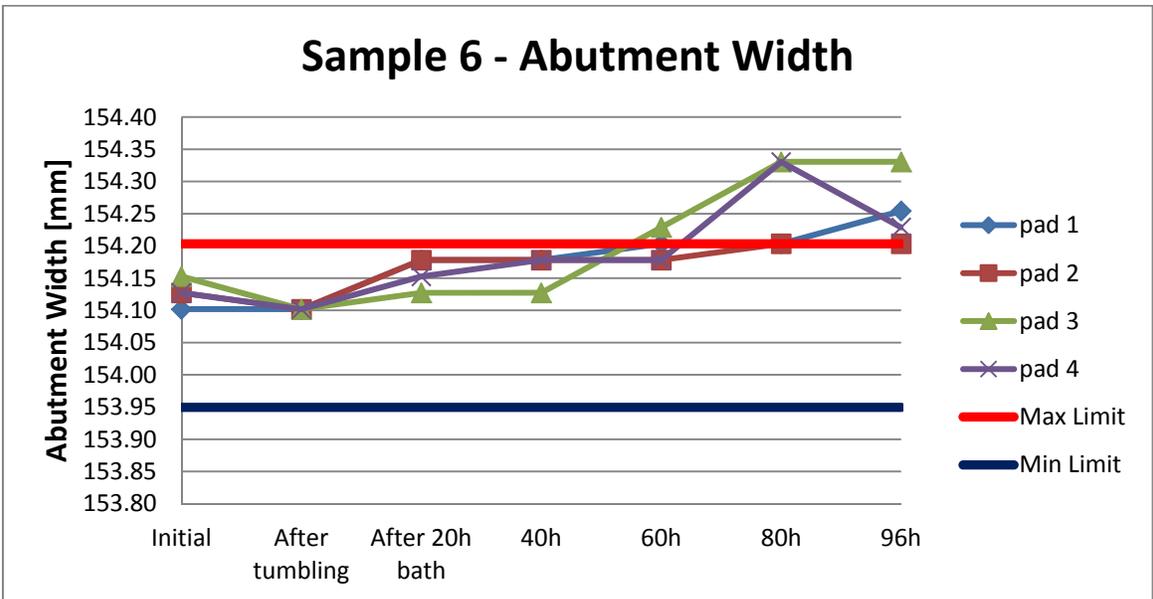
Figure 33 - Sample set 6 - OES

- Dimensional growth of all samples in this set exceeded the upper tolerance limit.

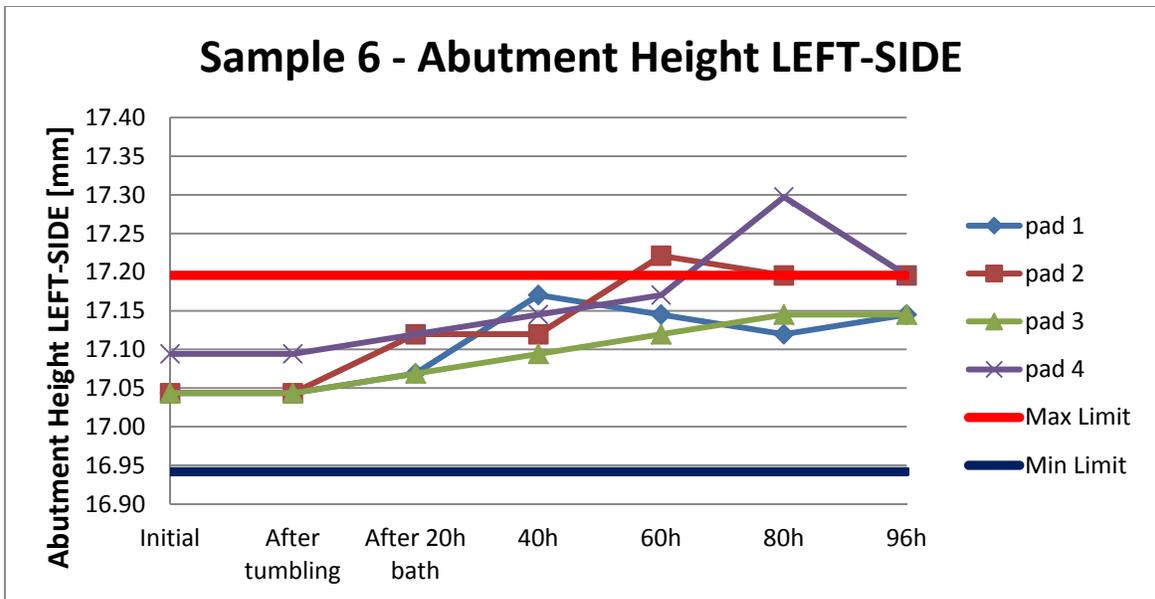
Figure 37 - Sample set 6 - OES

- Dimensional growth of samples 6.2 and 6.4 exceeded the upper tolerance limit.
- Samples 6.1 and 6.3 remained within tolerance.

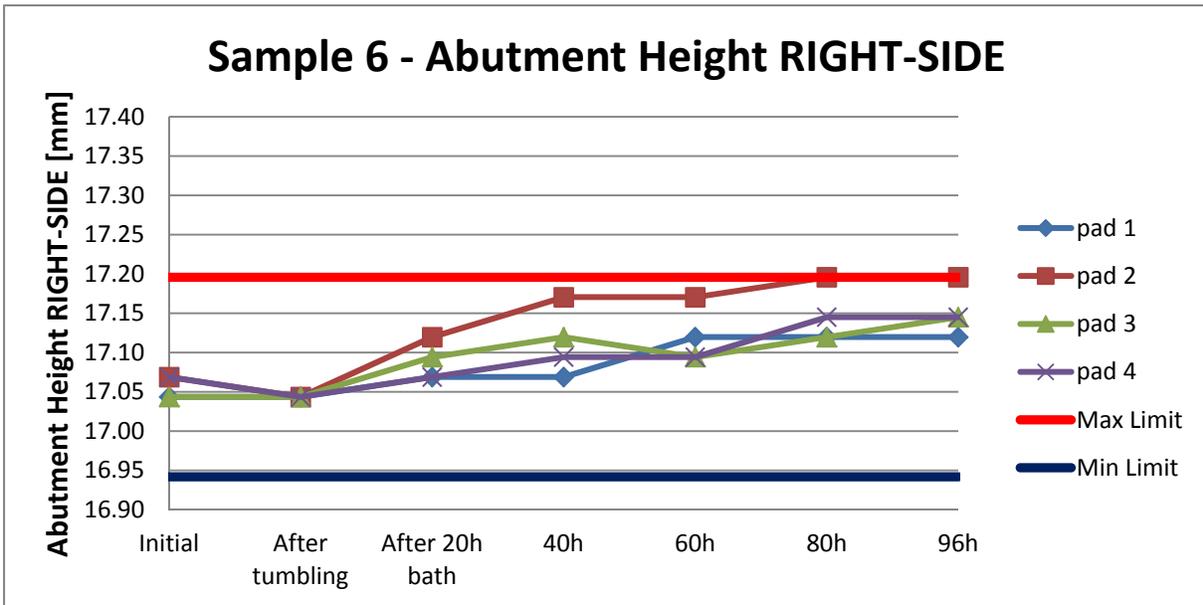
Figure 41 - Sample set 6 - OES

- Sample 6.2 reached the upper tolerance limit at 80 hours.
- Samples 6.1, 6.3, and 6.4 remained within tolerance.

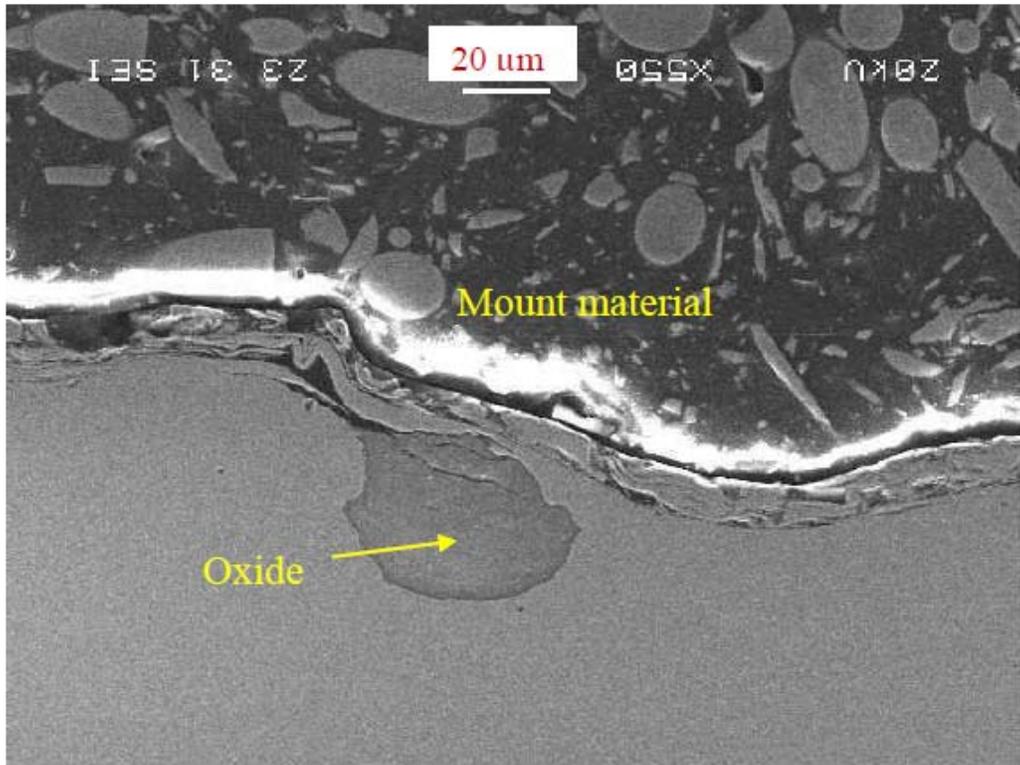
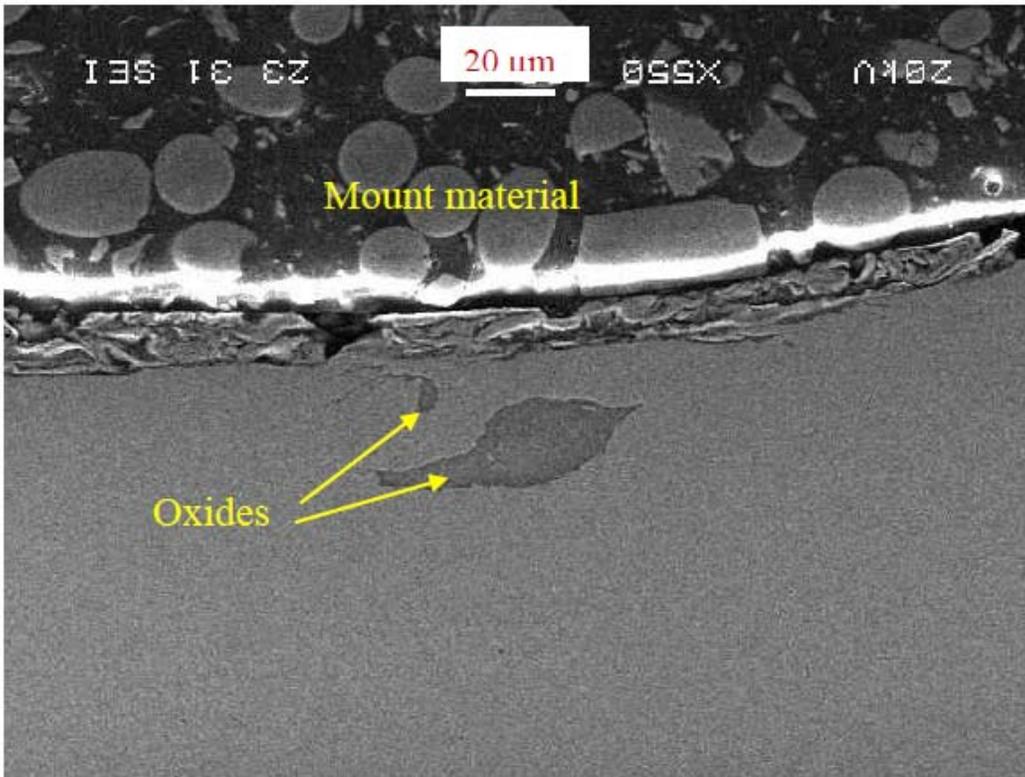
Figure 44 - Sample 3: Black steel, shot blasted with adhesive - SEM Image [6]

- Several embedded particles were found at some subsurface locations, see Figure 44.
- Oxide particles had a maximum length of approximately 55 microns. The grains were deformed at the surface, see Figure 45.

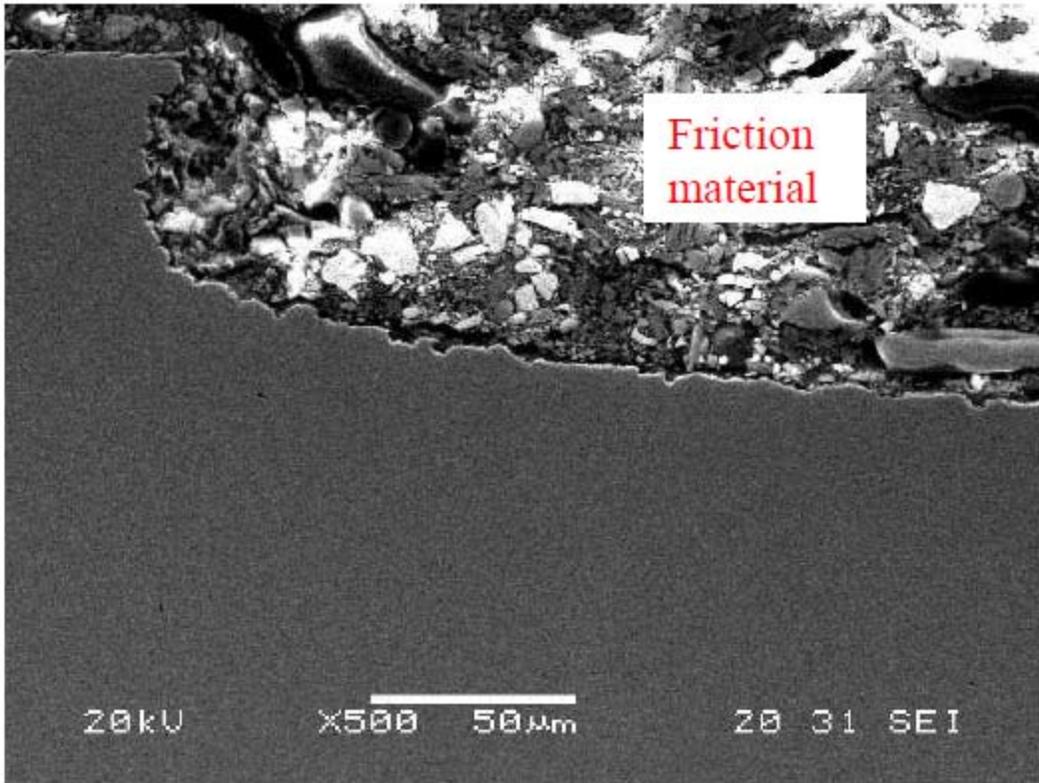
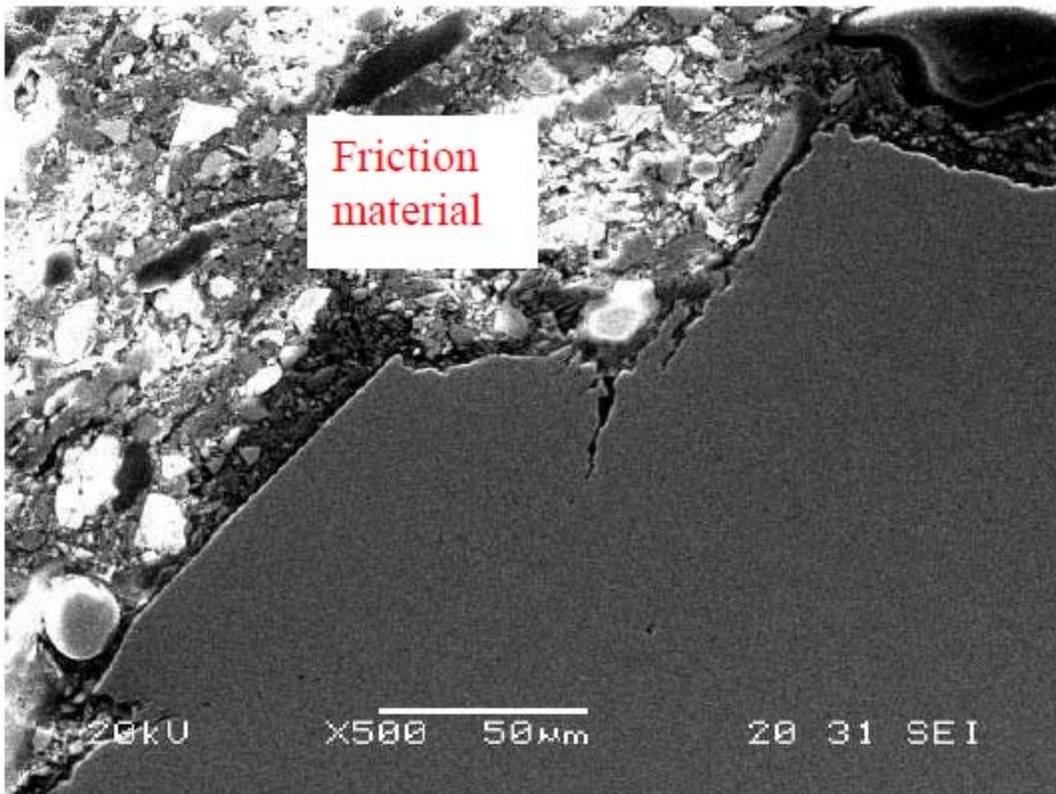
Figure 46 - Sample 7: Disc brake shoe - SAE 1010 HRPO, painted - SEM Image [6]

- No oxides or embedded particles were found, see Figure 46.
- No grain deformation was observed, see Figure 47.

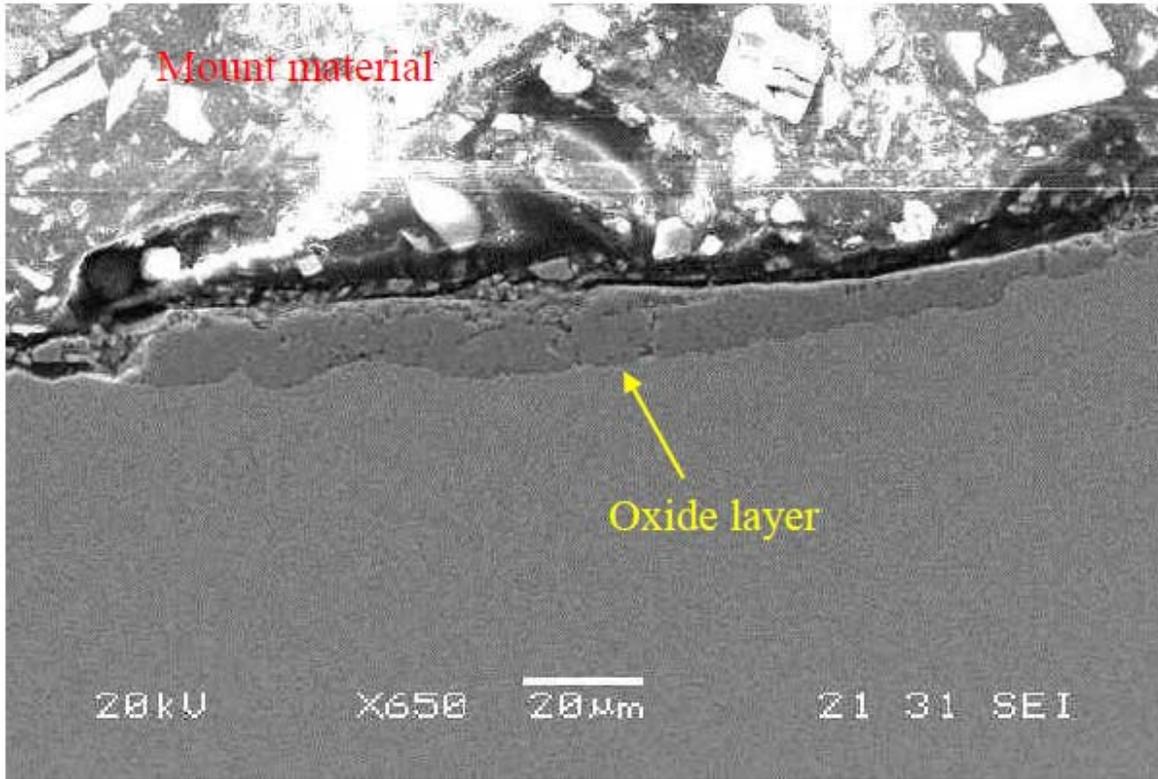
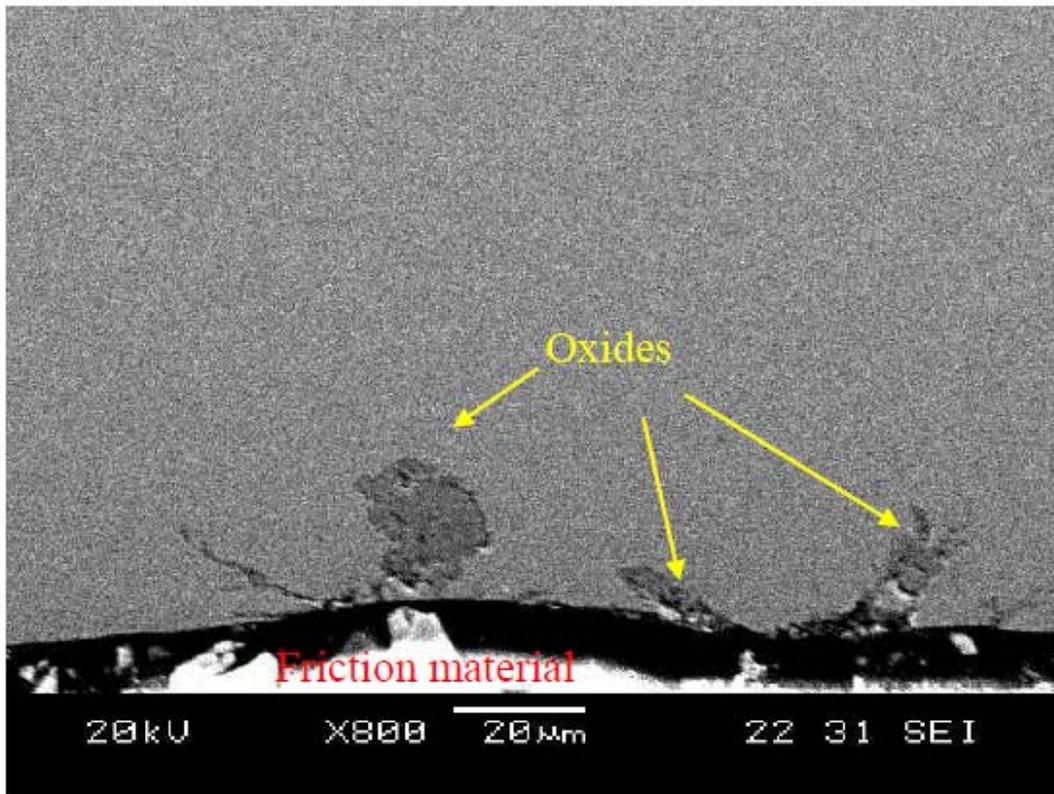
Figure 48 - Sample 8: Disc brake shoe - suspected black steel, painted - SEM Image [6]

- An oxide layer with a thickness of approximately 10 microns was observed inside the blind hole. An embedded oxide layer was observed at the surface interface of steel and friction, see Figure 48.
- The grains were deformed at the surface; the oxide layer is shown in Figure 49.

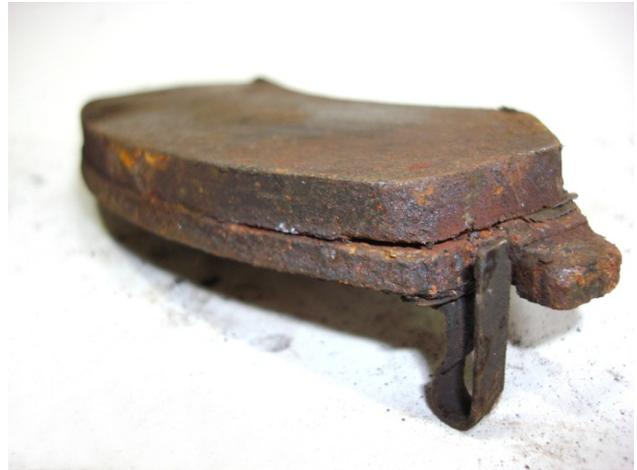
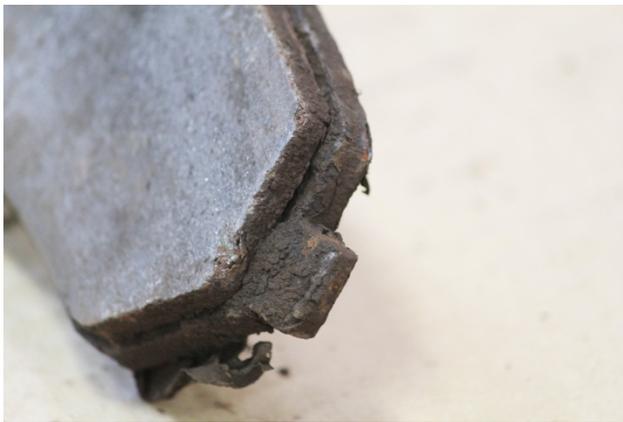
Figure 50 - Failed Disc Brake Pad Field Samples - Rust jacking

Images (a) to (d) show examples of severe rust jacking. Notice there is plenty of friction lining remaining on the pad in (b). Rust jacking in (d) is more severe and has lifted a significant portion of friction lining off the shoe.

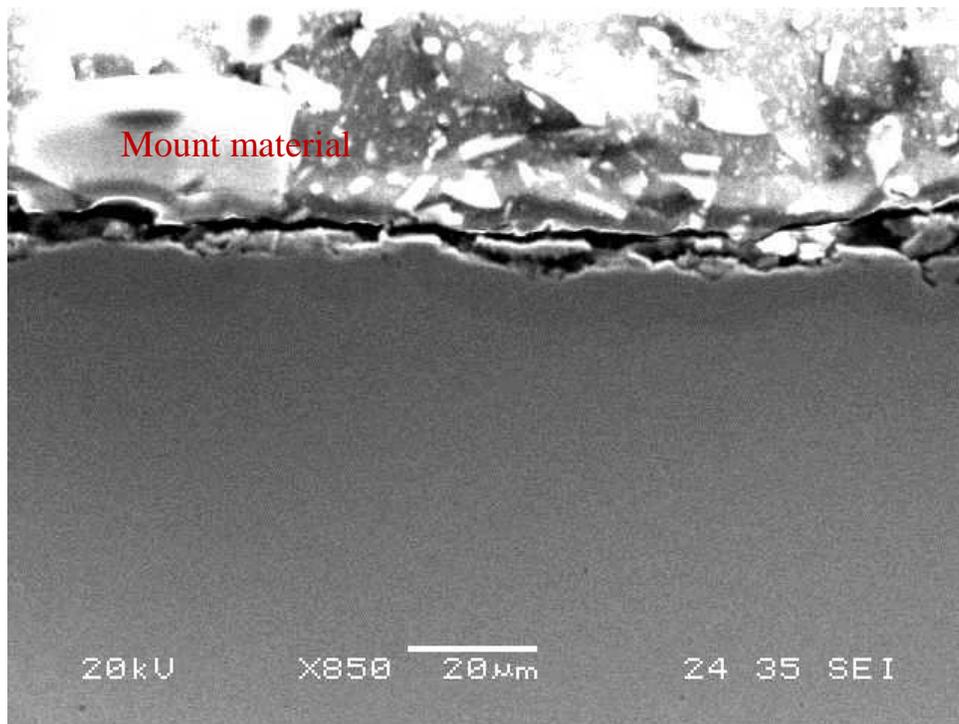
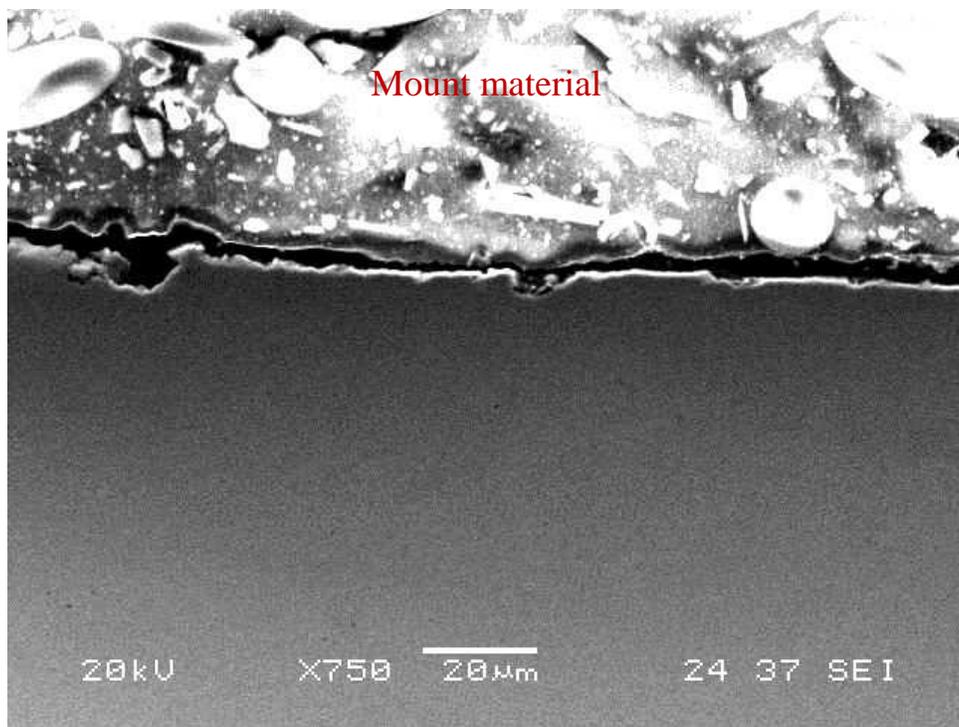
Figure 7: Selected SEM images of the surface of sample “4”, SAE 1010 HRPO steel (5”x2”). No oxide particles were observed.

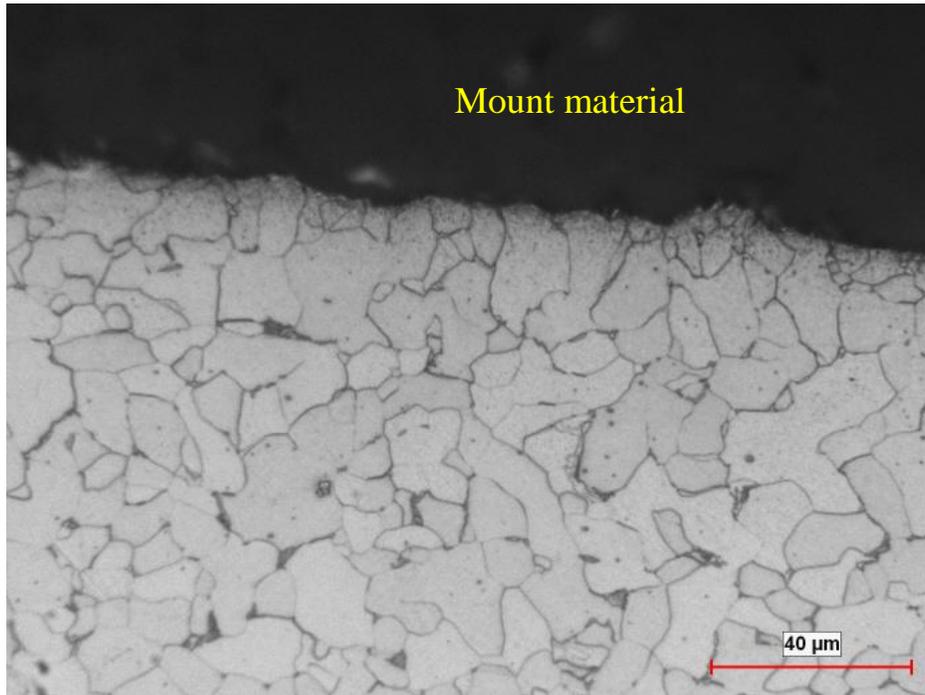
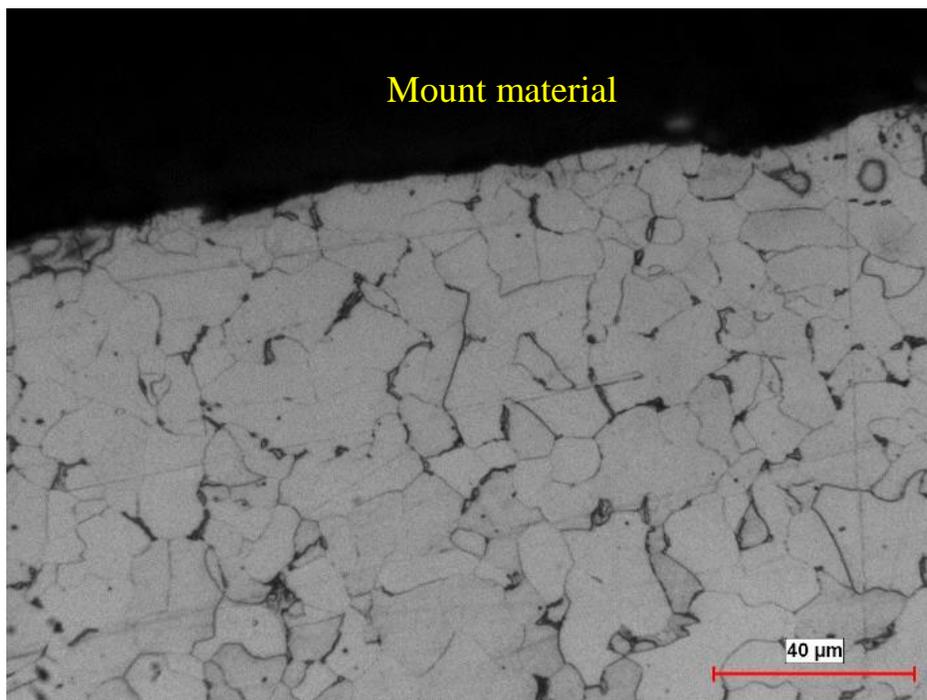
Figure 8: Optical micrographs illustrating the microstructure of sample “4”, SAE 1010 HRPO steel (5”x2”) at the surface. The microstructure was composed of ferrite (light) and pearlite (dark). No oxides were observed. The microstructure was not deformed at the surface (etched with 3% Nital, original magnification: 500X).

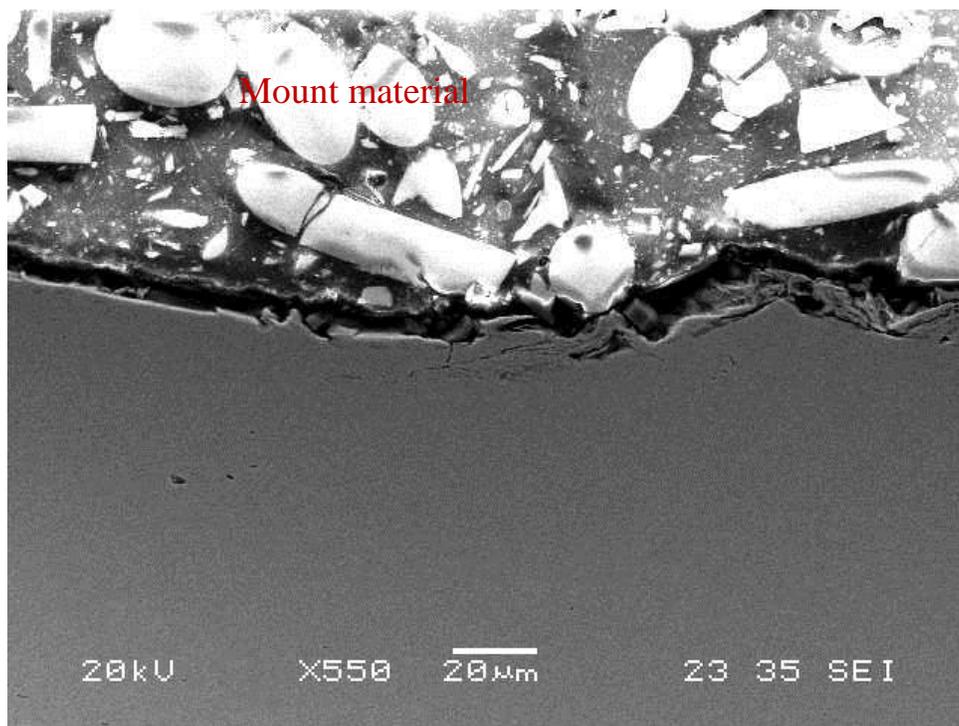
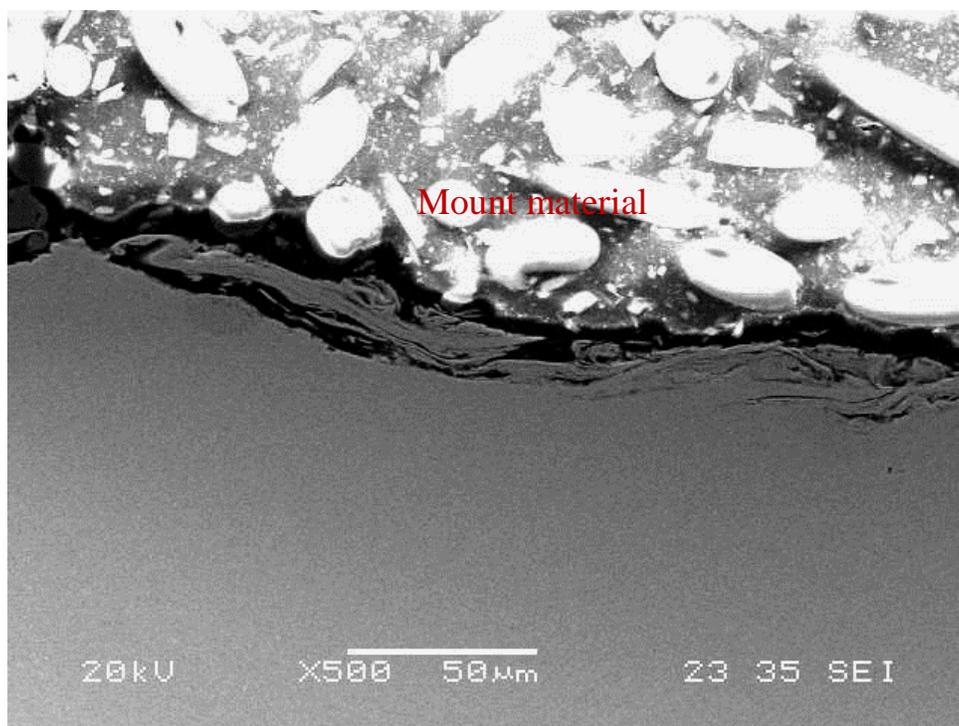
Figure 9: Selected SEM images taken from the surface of sample “5”, SAE 1010 HRPO steel (5”x2”). No oxide particles were observed.

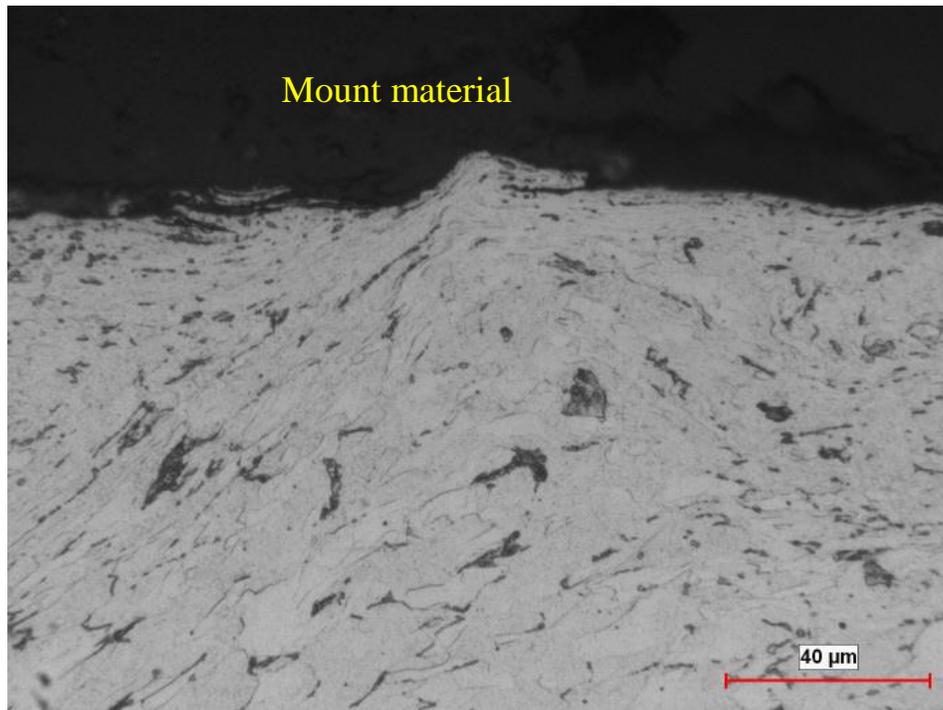
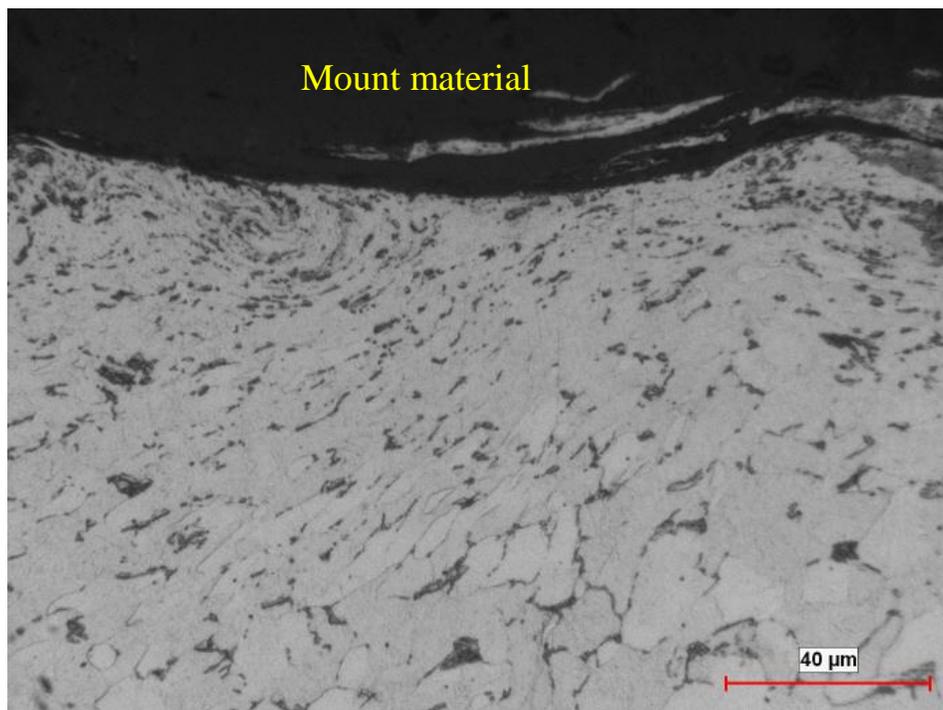
Figure 10: Optical micrographs illustrating the microstructure of sample “5”, SAE 1010 HRPO steel (5”x2”) at the surface. The microstructure was composed of ferrite (light) and pearlite (dark). The microstructure was deformed at the surface. No oxides were observed (etched with 3% Nital, original magnification: 500X).

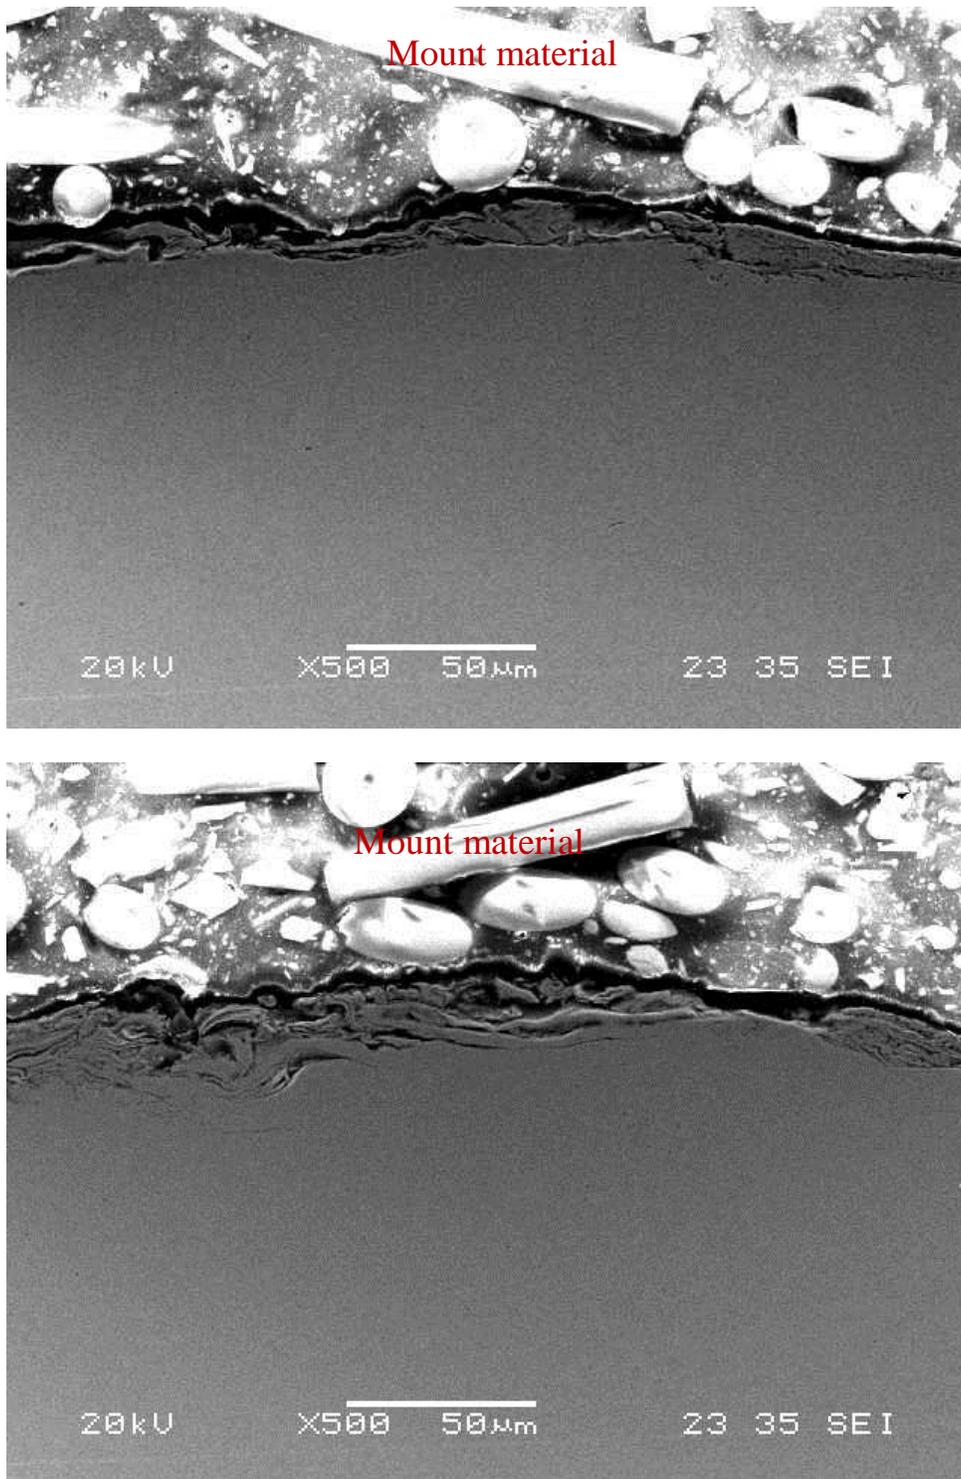
Figure 11: Selected SEM images taken from the surface of sample “6”, SAE 1010 HRPO steel (5”x2”). No oxide particles were observed.
