EFFECTS OF 'BLACK STEEL' AND ITS CONTRIBUTION TO PREMATURE BRAKE PAD REPLACEMENT AND BRAKE PAD FAILURE

Abstract

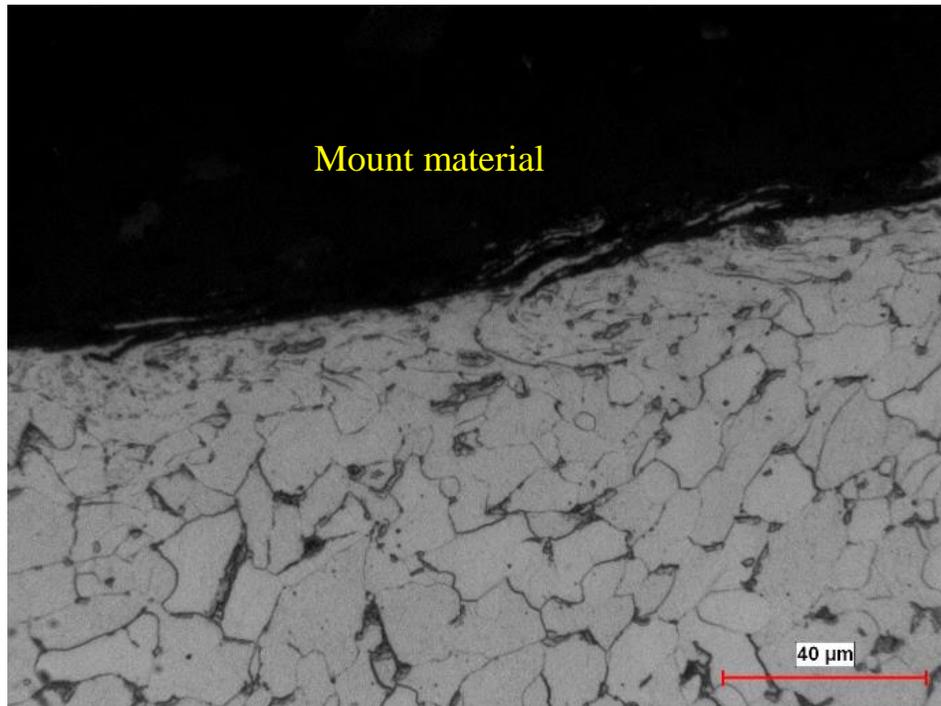
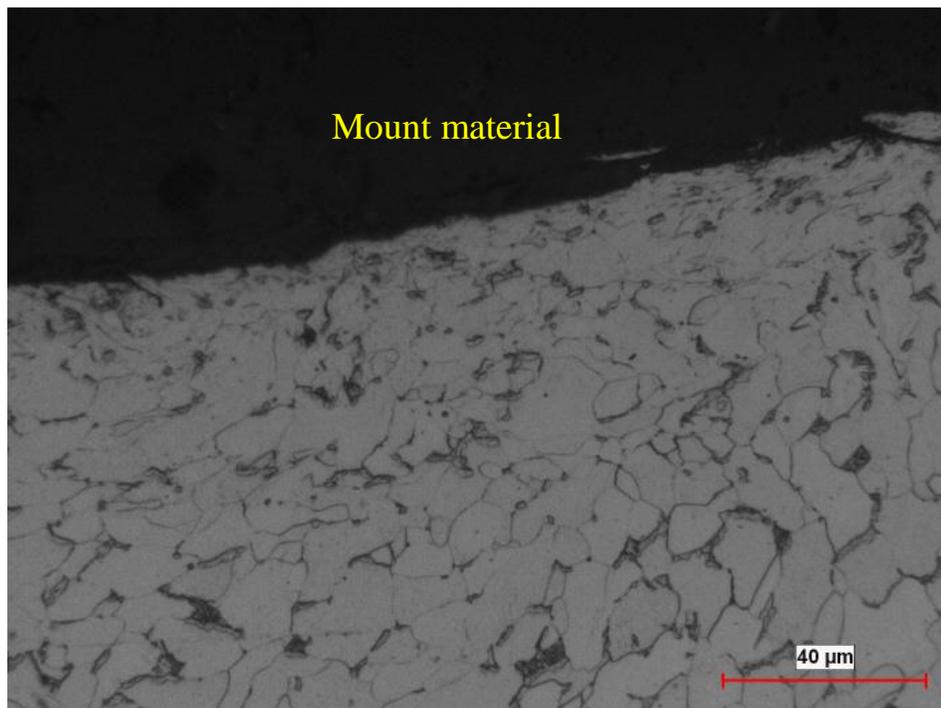
Figure 12: Optical micrographs illustrating the microstructure of sample “6”, SAE 1010 HRPO steel (5”x2”) at the surface. The microstructure was composed of ferrite (light) and pearlite (dark). A shallow region with a deformed microstructure was observed at the surface. No oxides were found (etched with 3% Nital, original magnification: 500X).

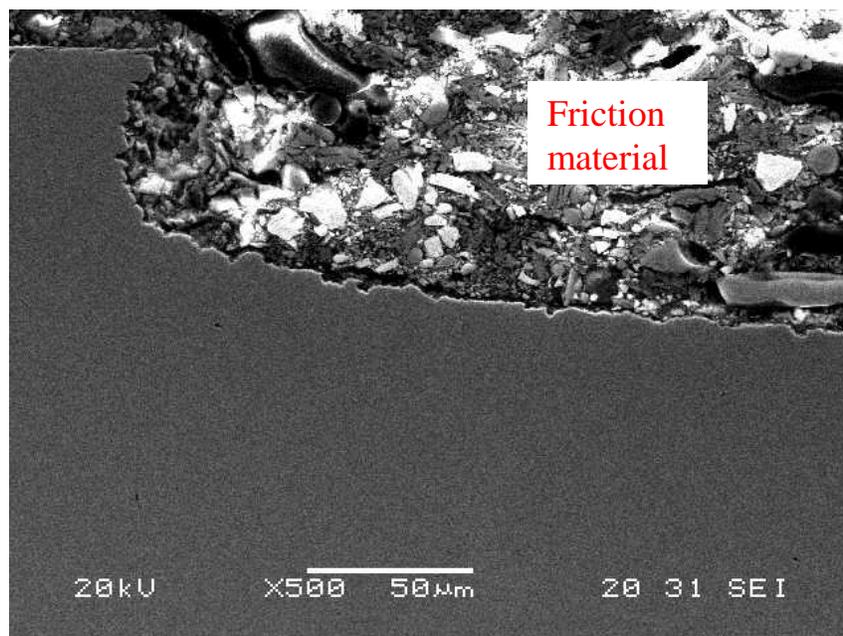
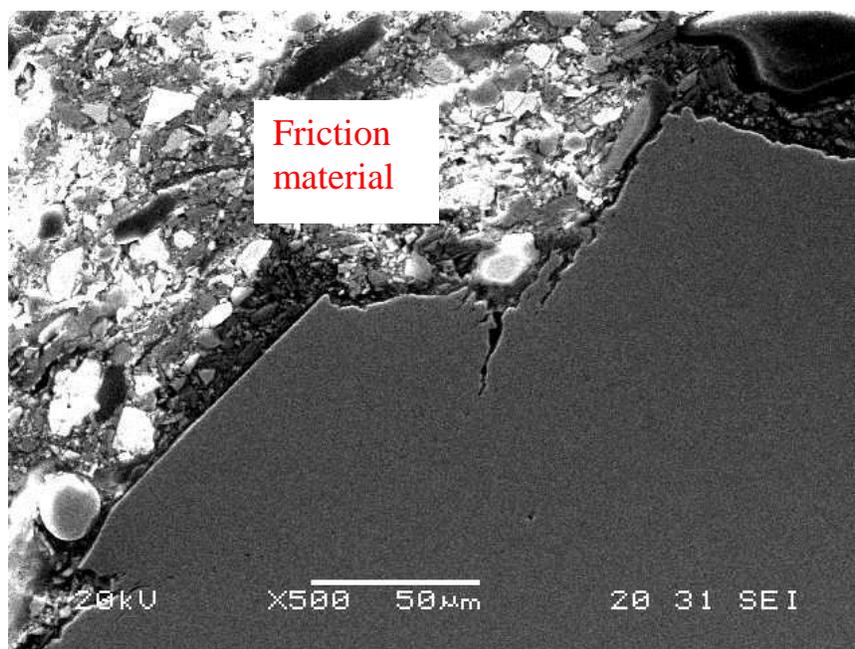
Figure 13: Selected SEM images of the surface of sample “7”, D833 (SAE 1010 HRPO). No oxide particles were observed.

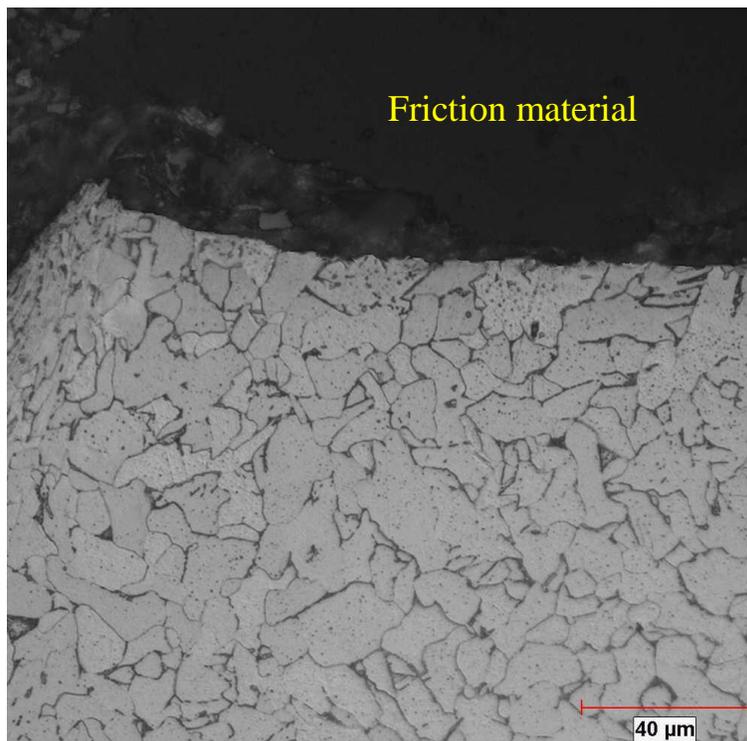
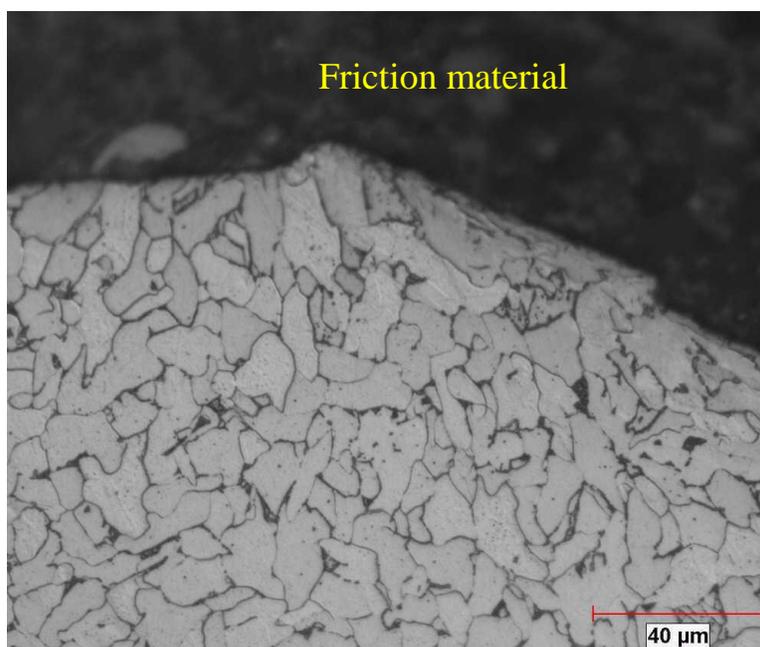
Figure 14: Optical micrographs showing the microstructure at the surface of sample “7” D833 (SAE 1010 HRPO). The microstructure was composed of ferrite (light) and pearlite (dark). No grain deformation was observed (etched with 3% Nital, original magnification: 500X).

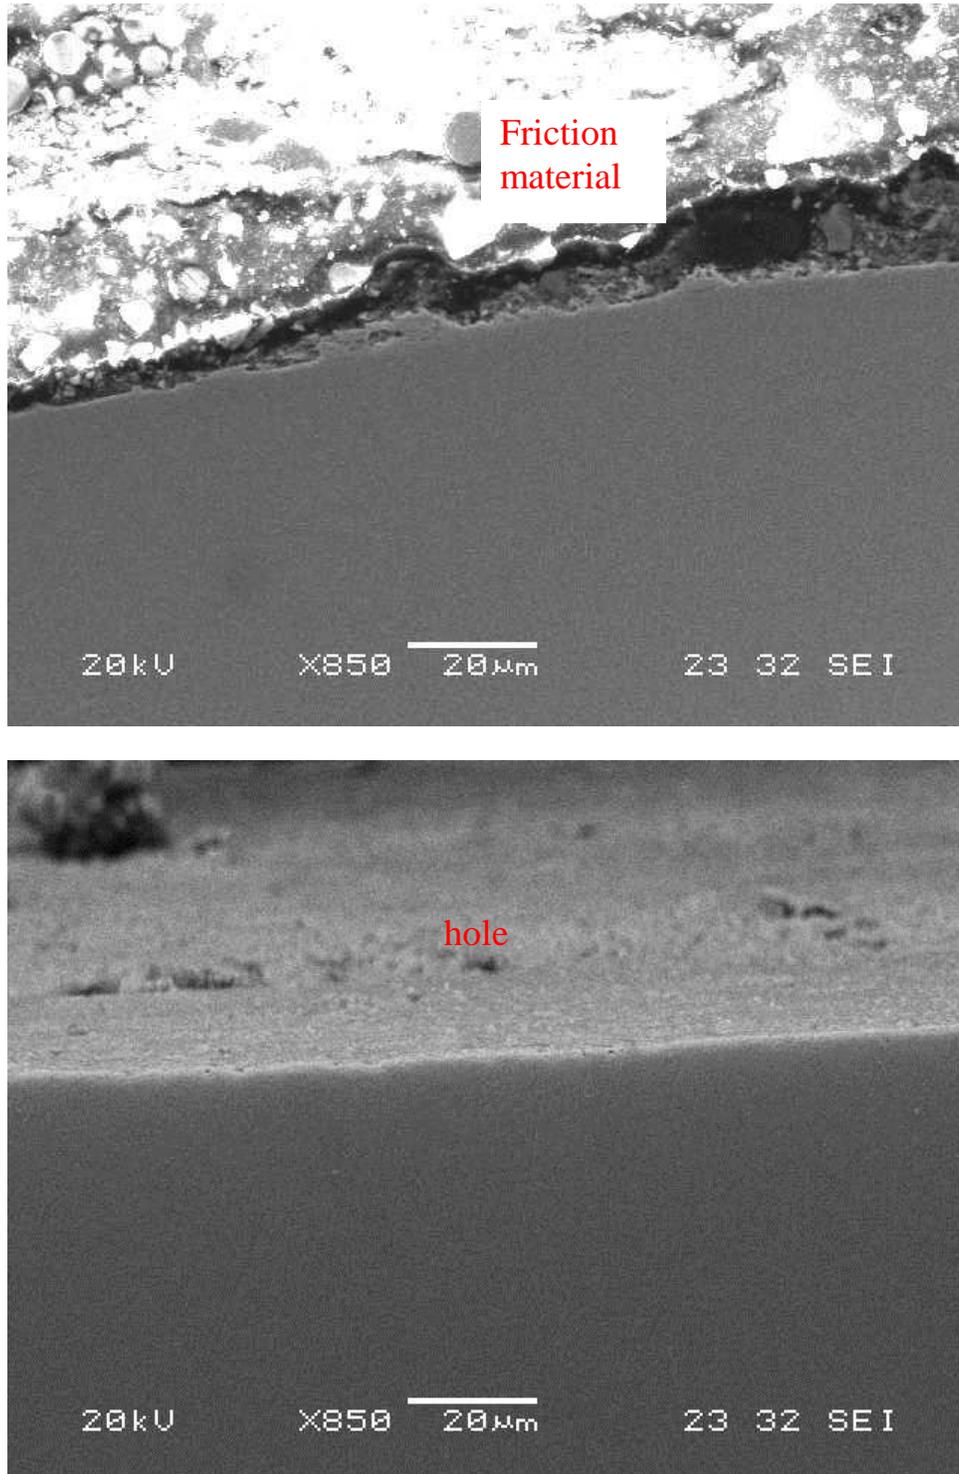
Figure 15: Selected SEM images of the surface of sample “7.1”, D833 (SAE 1010 HRPO). The bottom image was taken from the hole at the lug location. No oxide particles were observed.

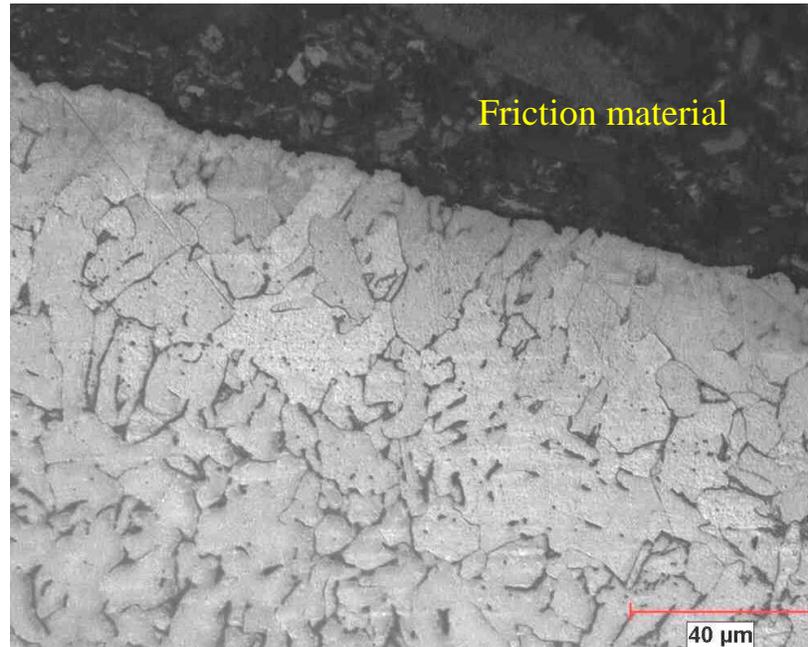
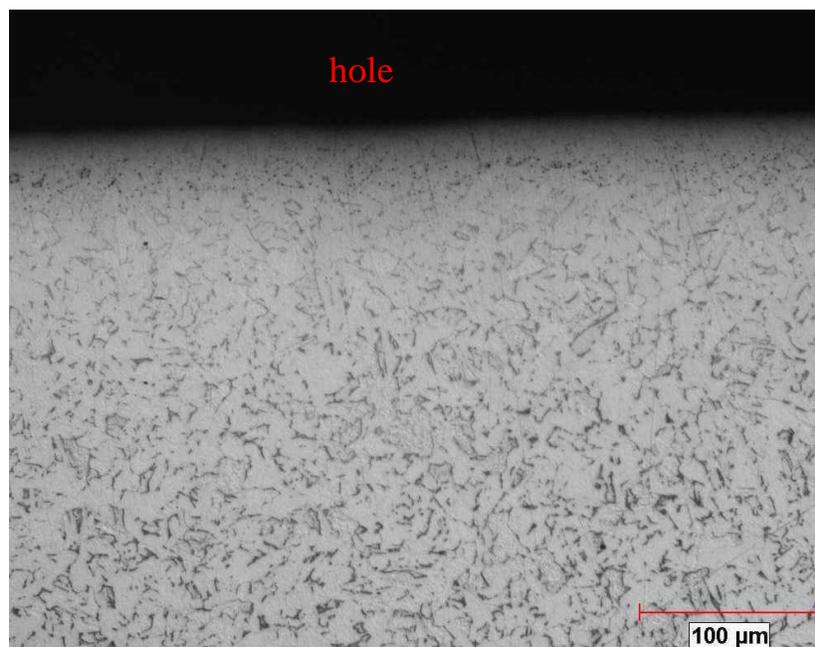
Figure 16: Optical micrographs showing the microstructure at the surface of sample “7.1” D833 (SAE 1010 HRPO). The bottom image was taken from the hole at the lug location. The microstructure was composed of equiaxed ferrite (light) and pearlite (dark). No grain deformation was observed (etched with 3% Nital, original magnification: top: 500X, bottom 200X).

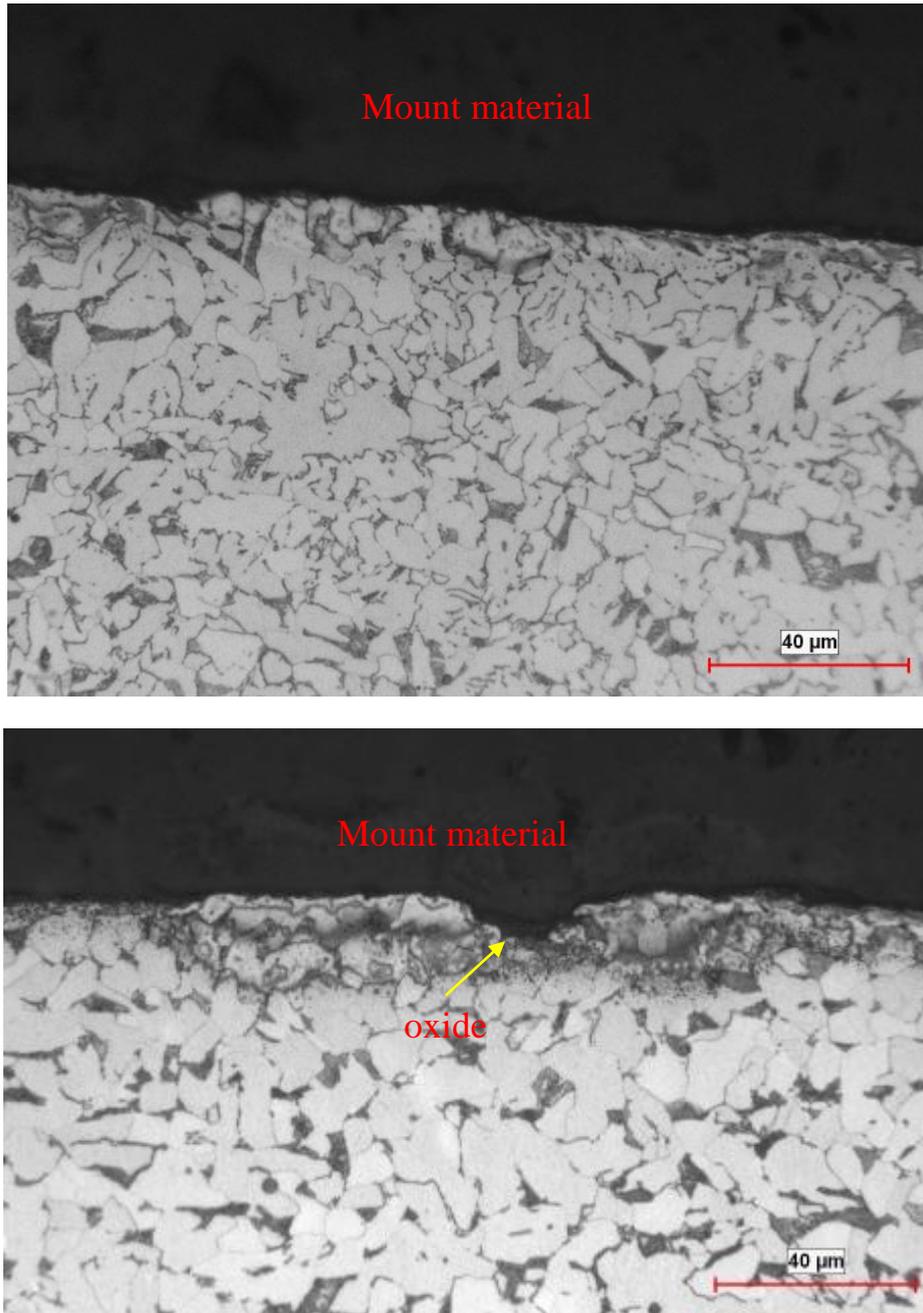
Figure 26: Optical micrographs illustrating the microstructure at the surface of sample “10”, D1282 (suspected black mill scale steel). The microstructure was composed of ferrite (light) and pearlite (dark). No deformed grains were observed (etched with 3% Nital, original magnification: 500X).

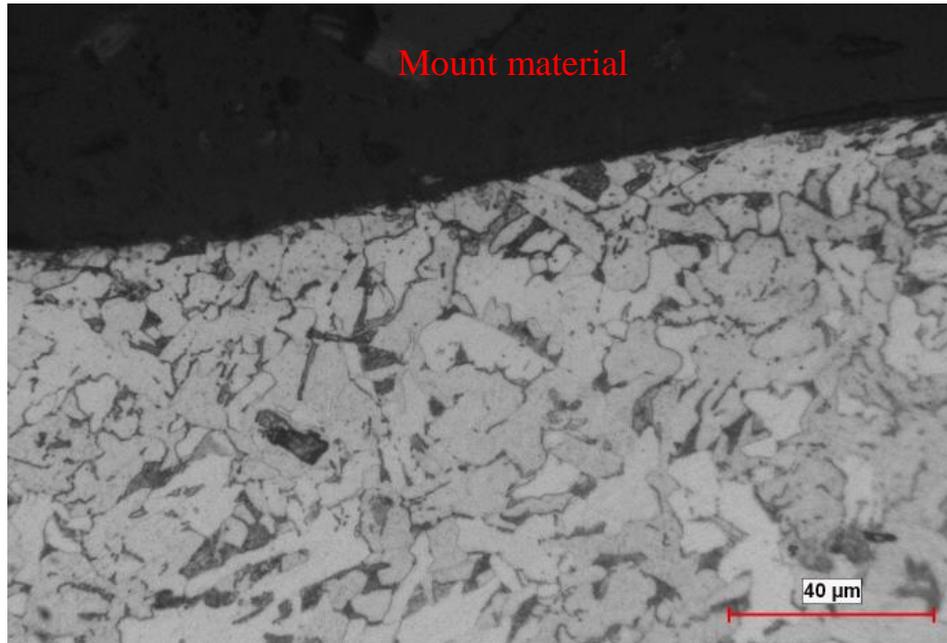
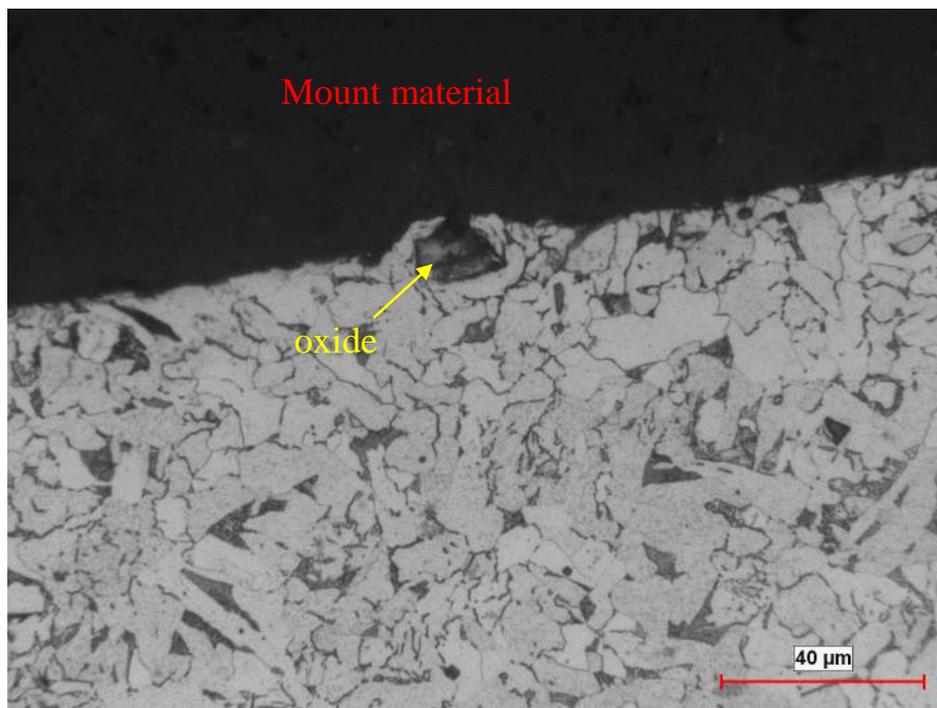
Figure 28: Optical micrographs illustrating the microstructure at the surface of sample "11", D1283 (suspected black mill scale steel). The microstructure was composed of ferrite (light) and pearlite (dark). No deformed grains were observed (etched with 3% Nital, original magnification: 500X).

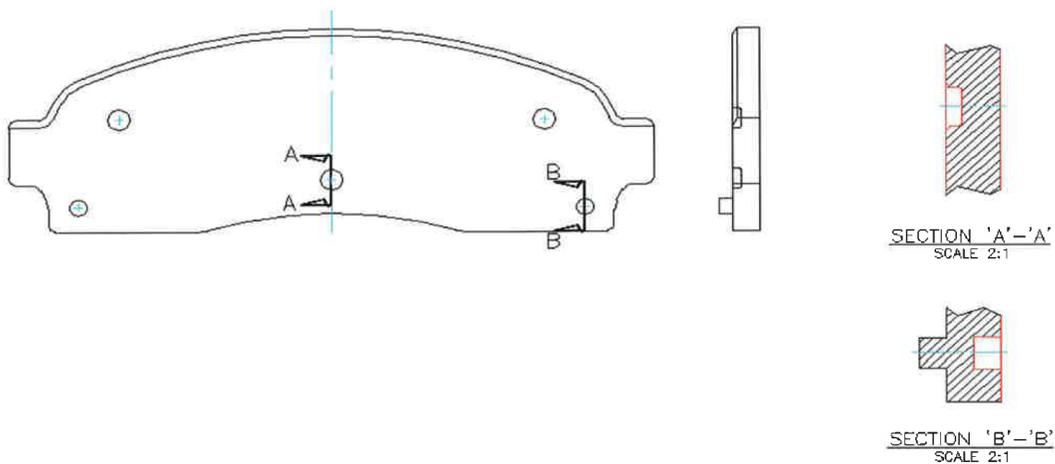
Red lines depict the areas on D833 in which we are interested for the microscopic analysis.
